Design and Operation Experience o f PLS-II Vacuum System

2015.01.25 Taekyun Ha, Chongdo Park

On behalf of Vacuum Group Pohang Accelerator Laboratory

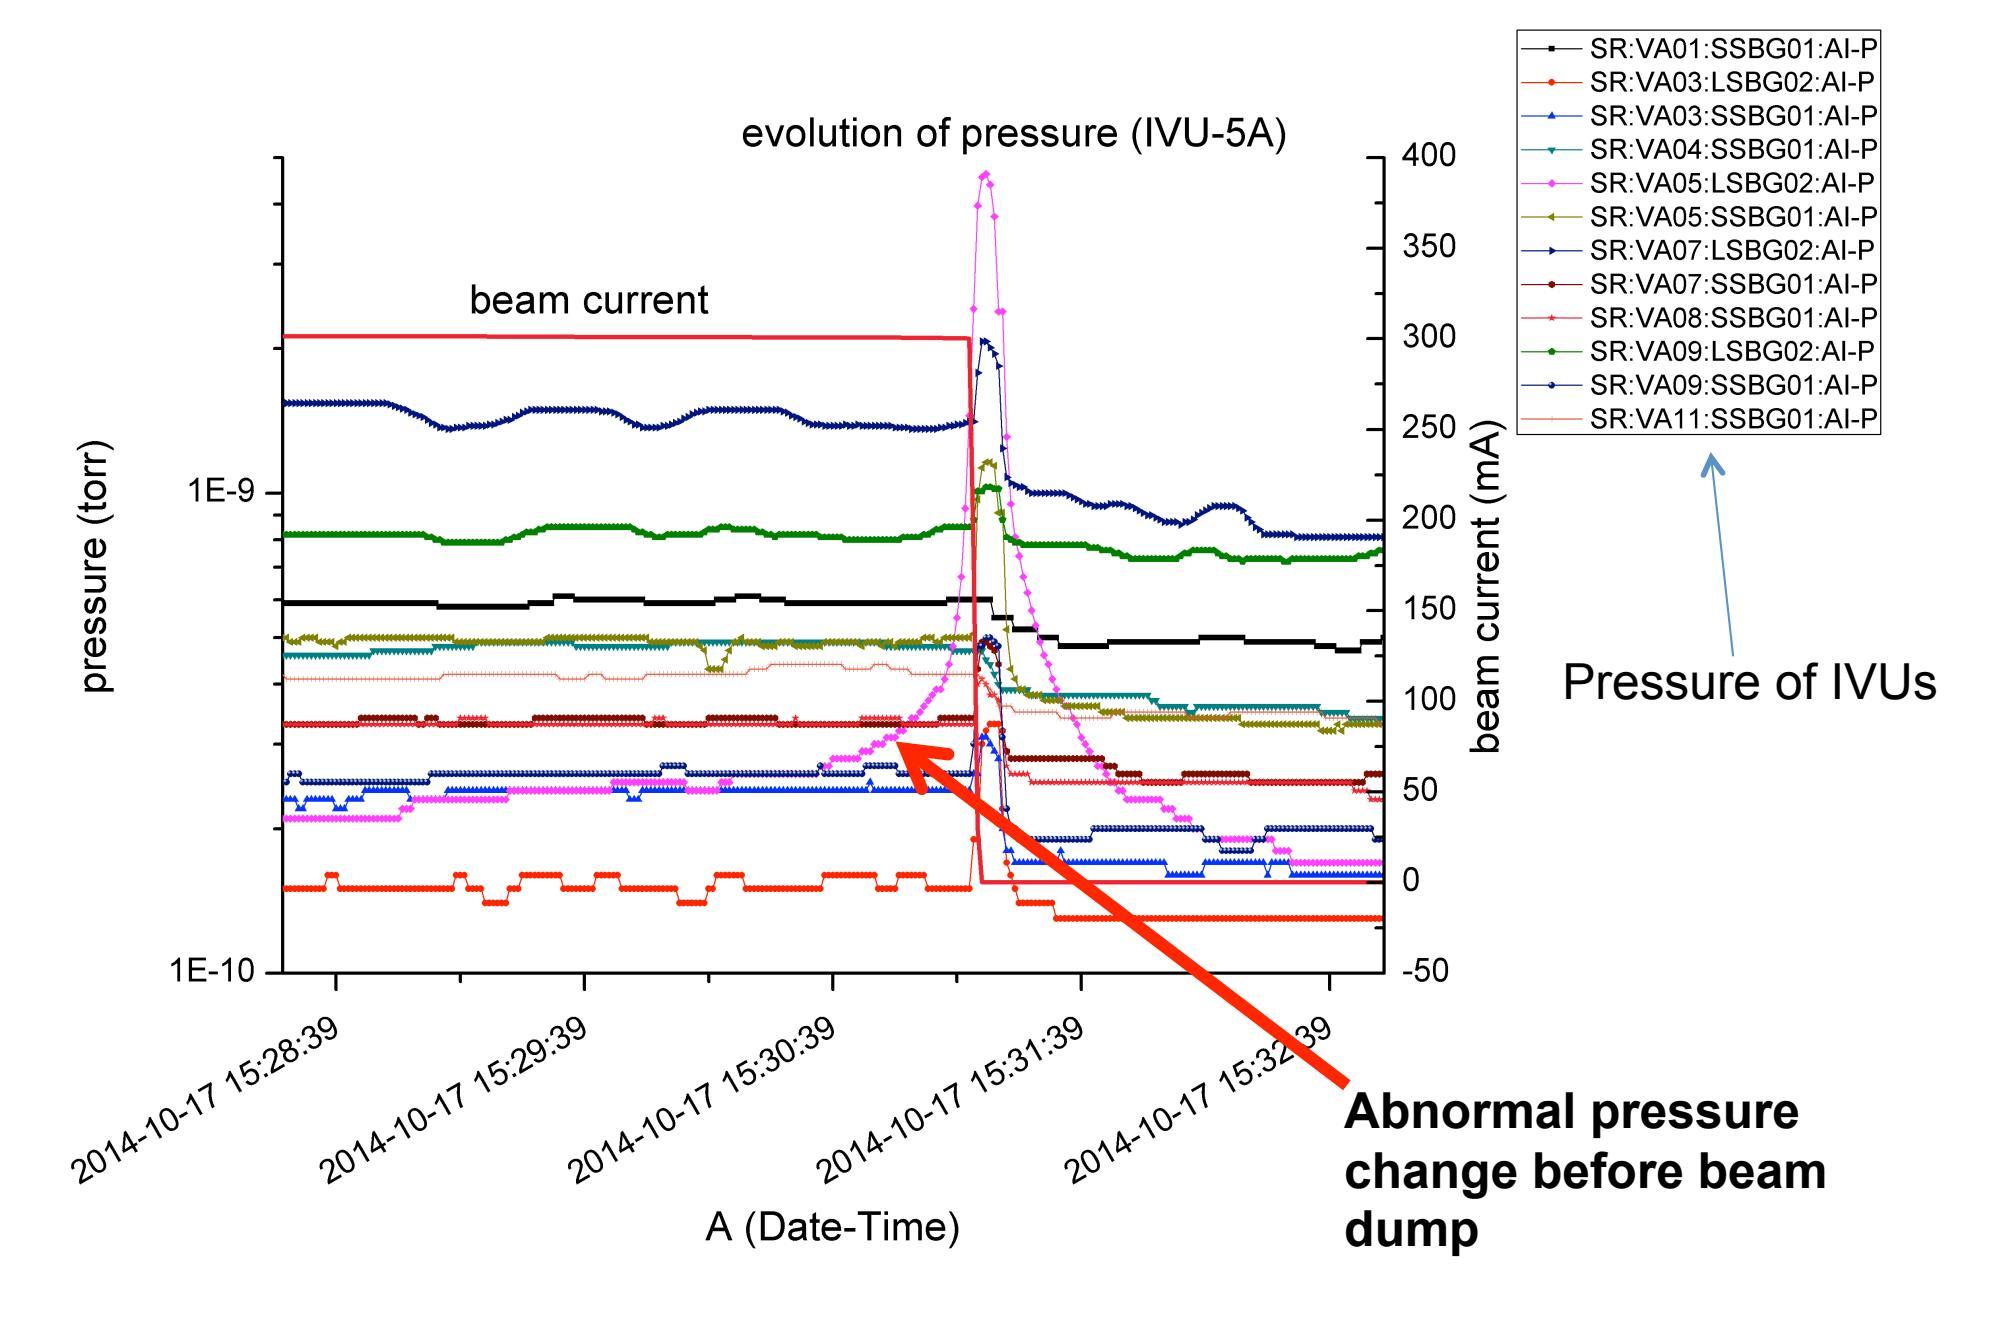
Beam dump due to the IVU foil bump

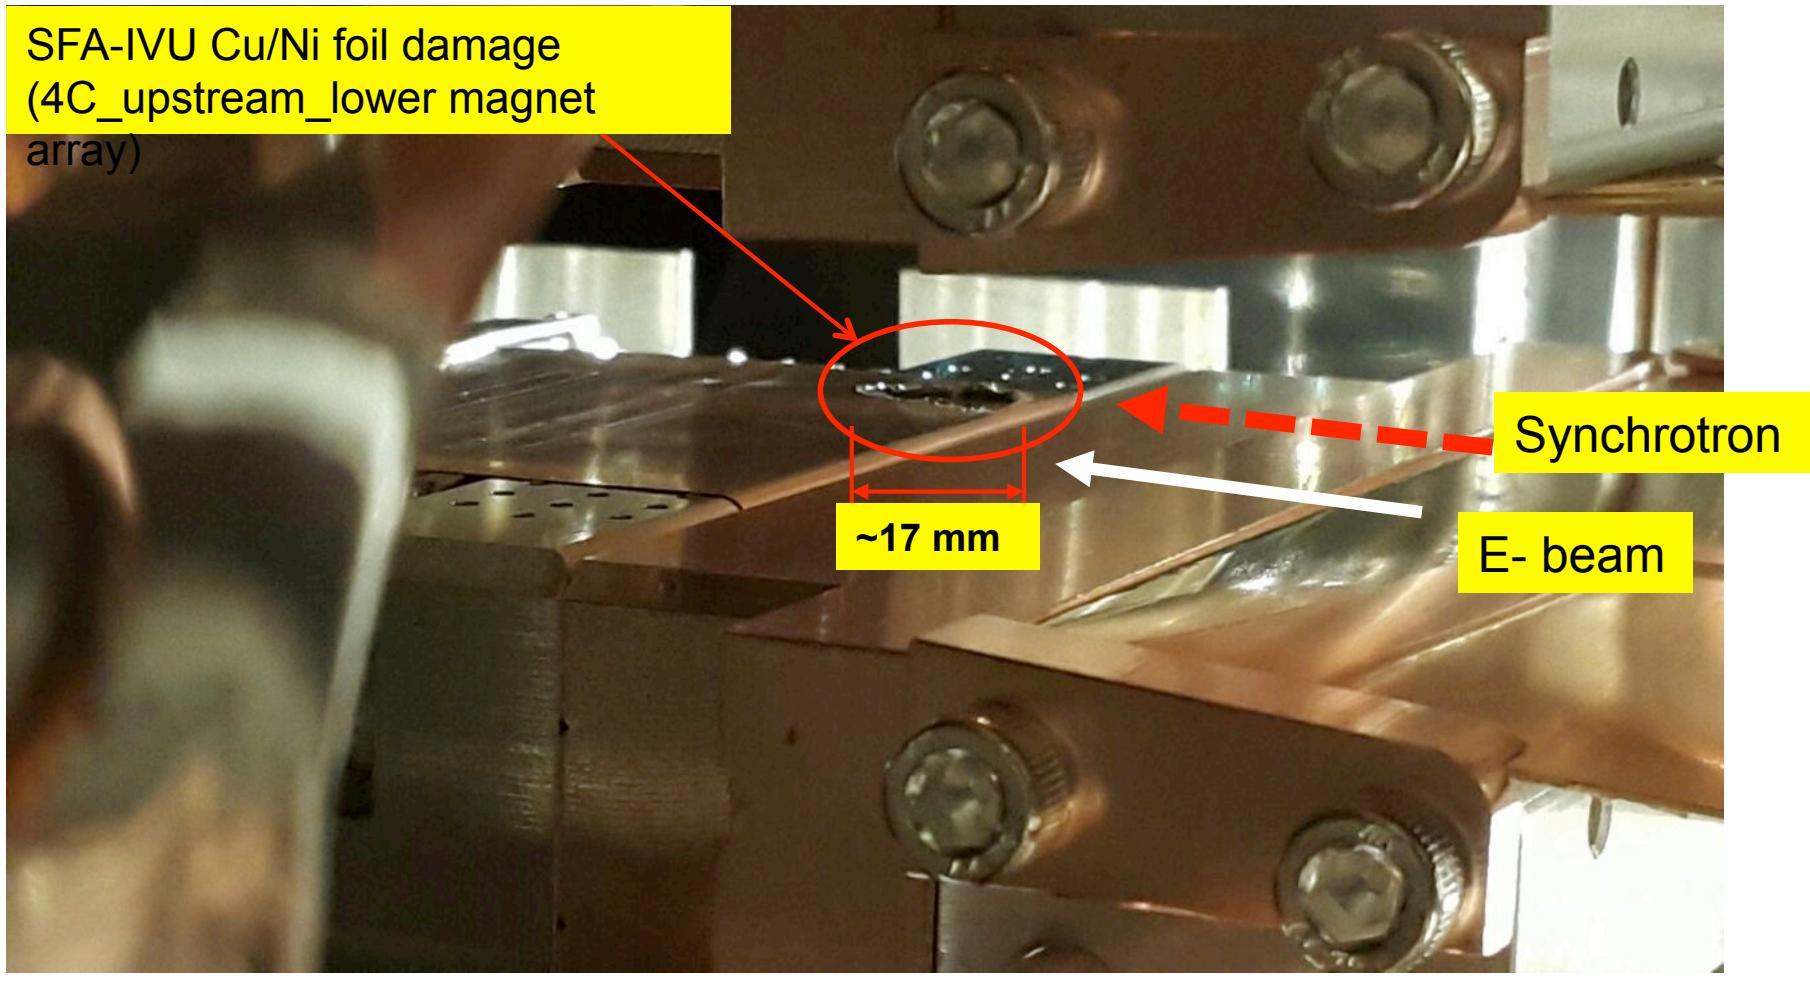
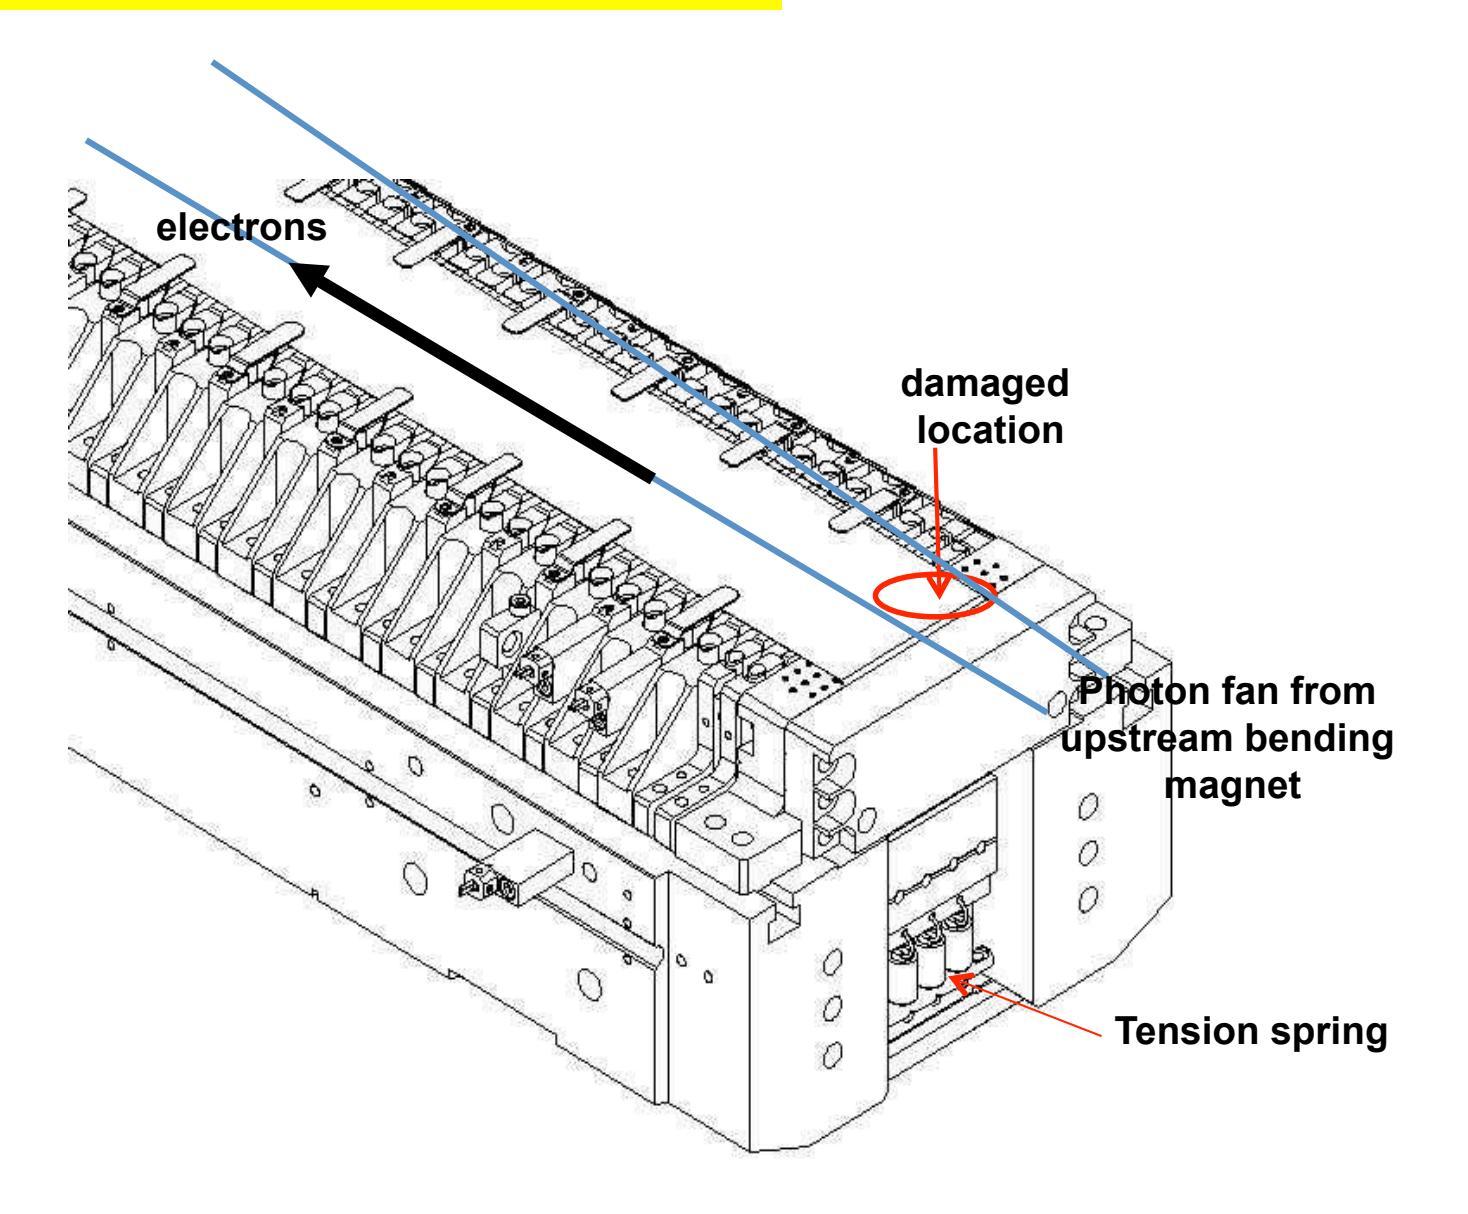
Damaged IVU (4C)

- 1. foil bump → image current heating → bump height \uparrow → synchrotron heating → foil melting (1,2,3 호기)
- 2. foil bump \rightarrow image current heating \rightarrow bump height $\uparrow \rightarrow$ Beam missteering (including mis-aignment) (lower foil only + cell 4,5)

SFA-IVU Cu/Ni foil damage (4C_upstream_lower magnet array)

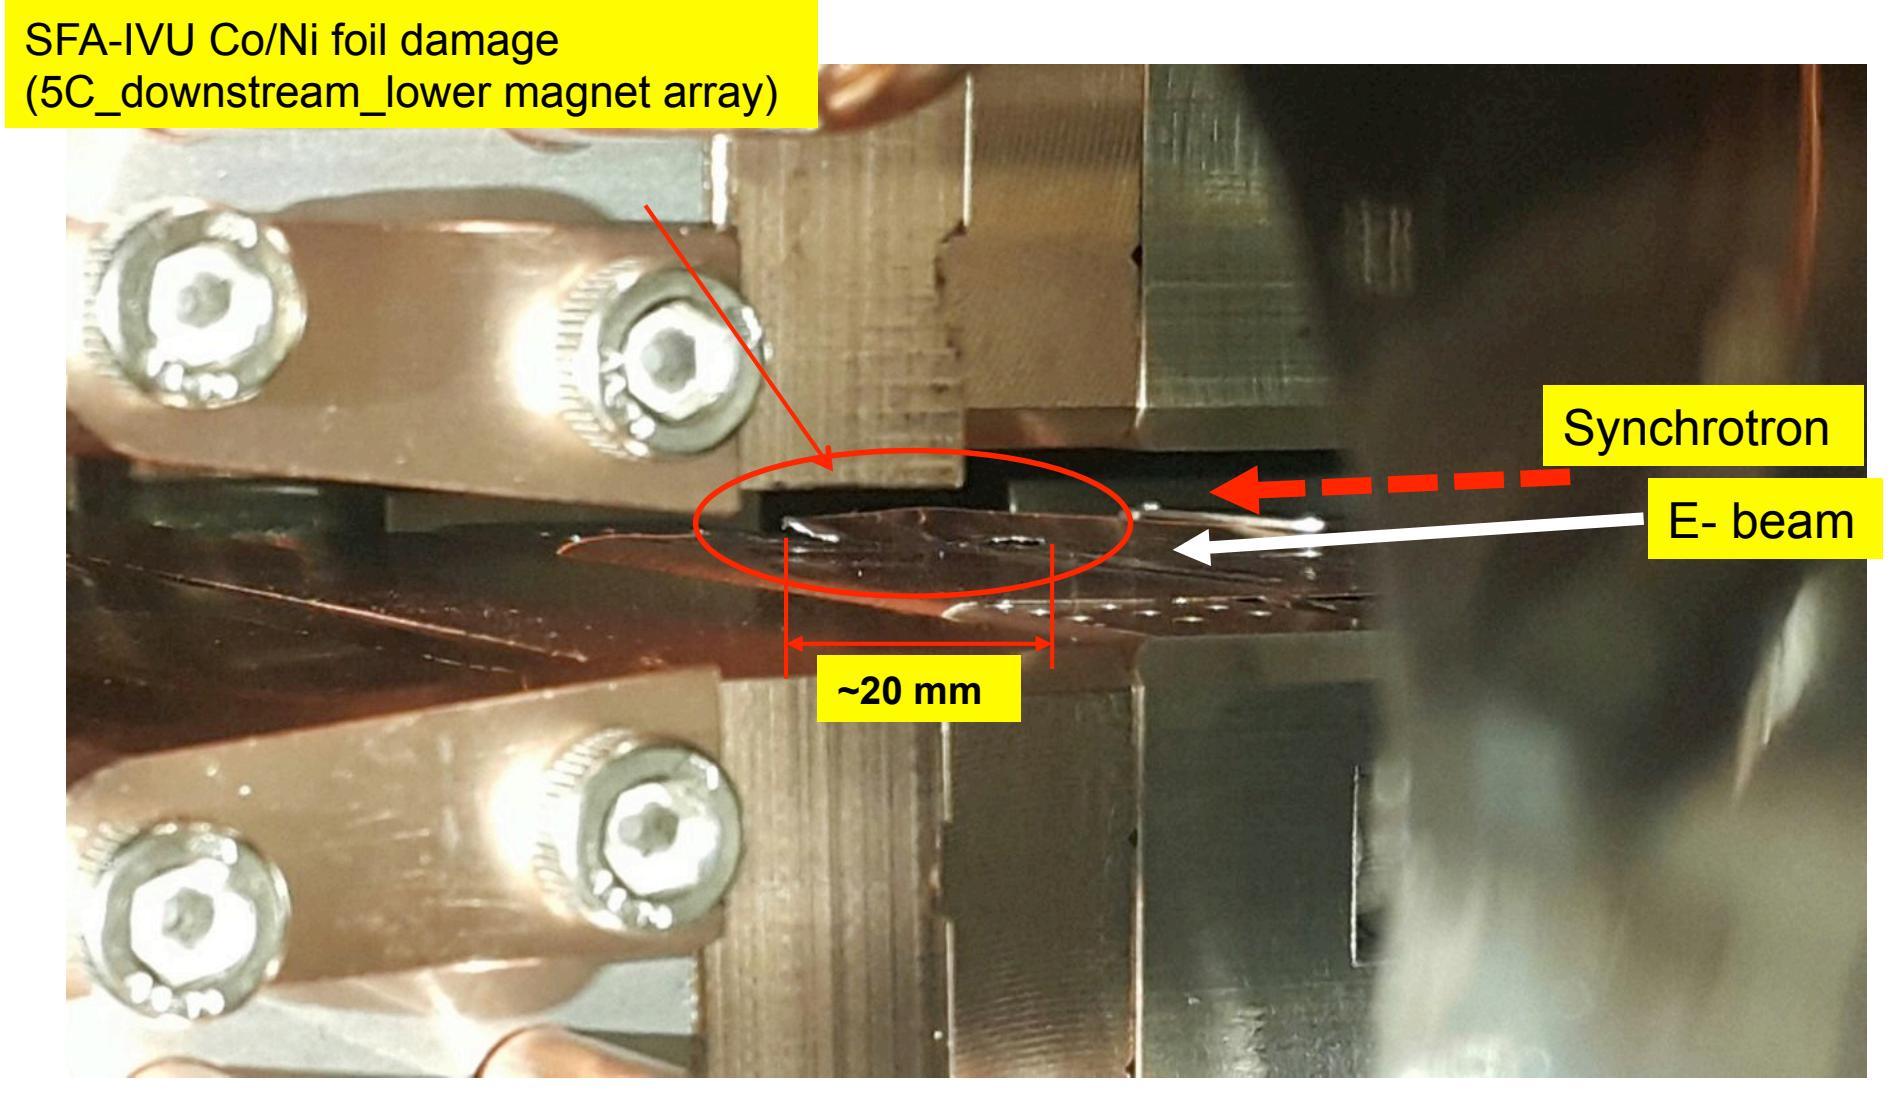
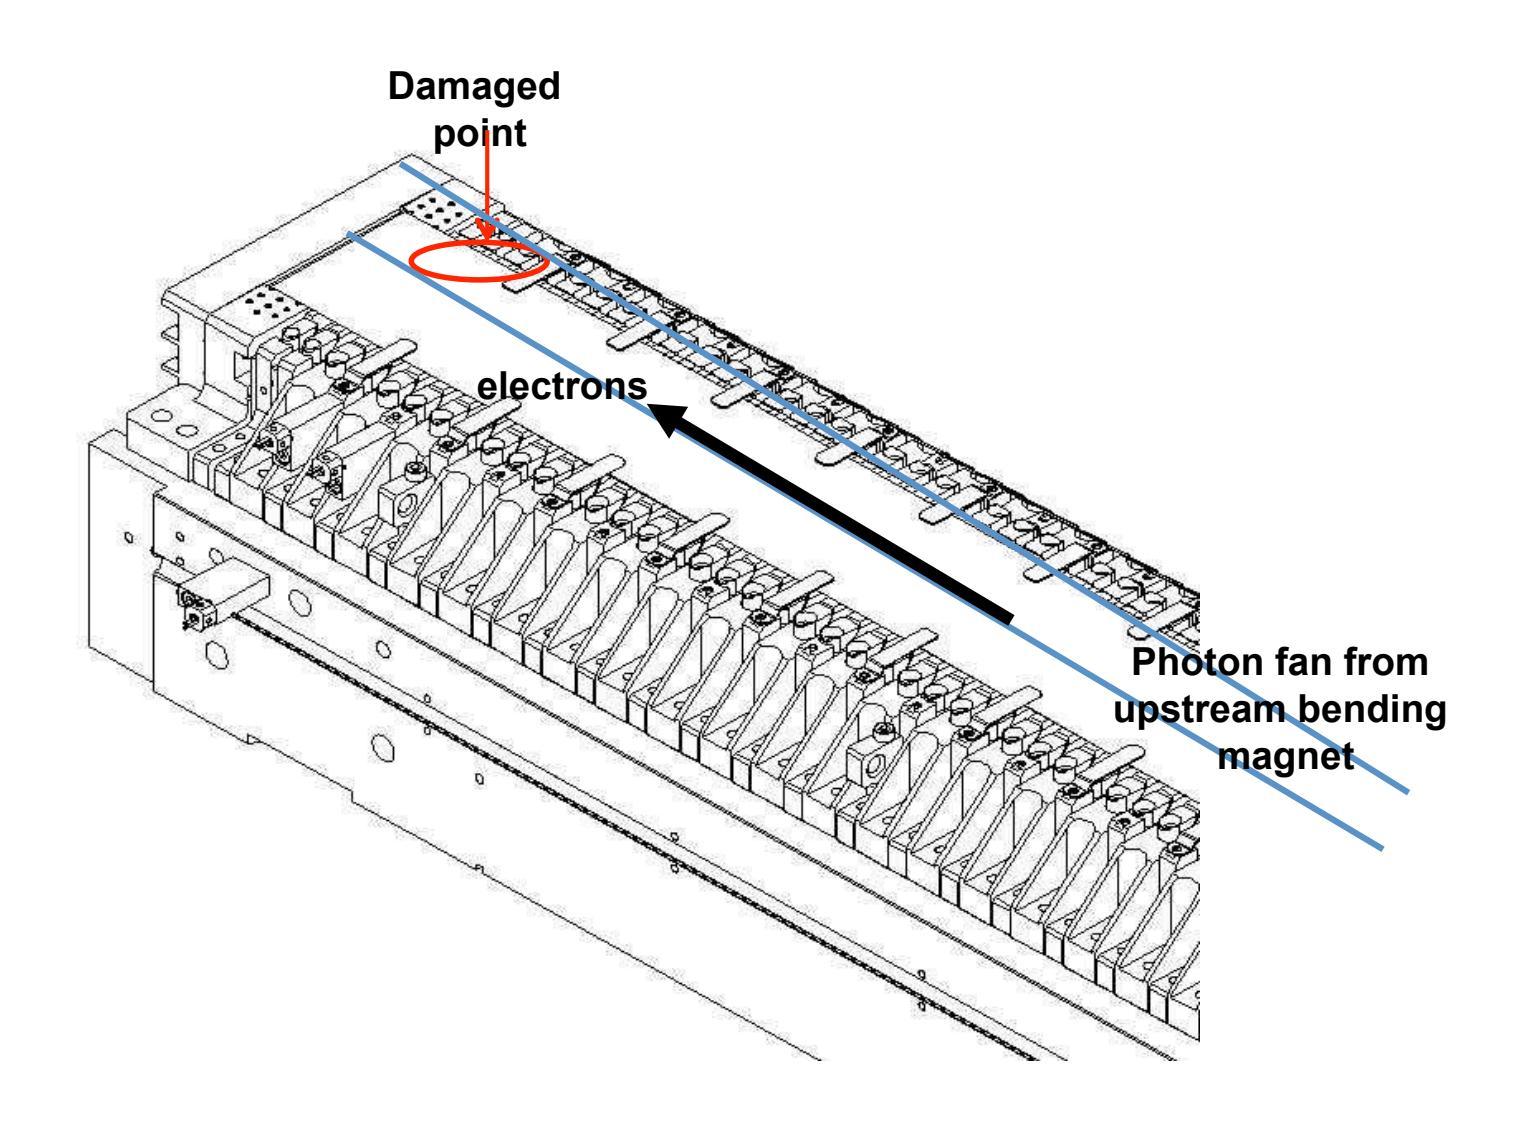
Damaged IVU (5C)

SFA-IVU Cu/Ni foil damage (5C_downstream_lower magnet array)

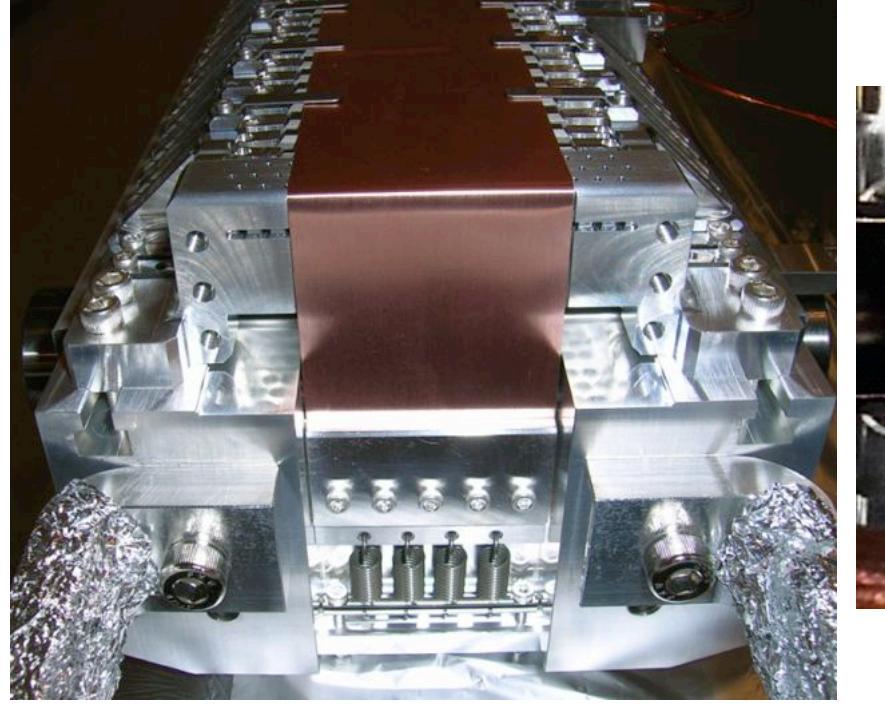
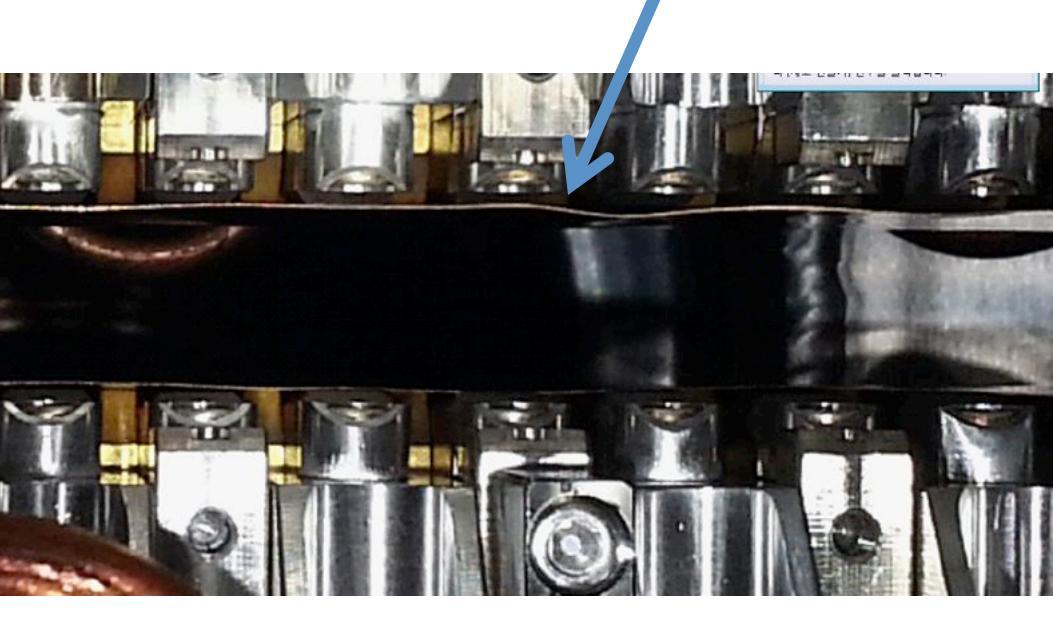
Inside of the IVU20

Uneven Cu/Ni foil

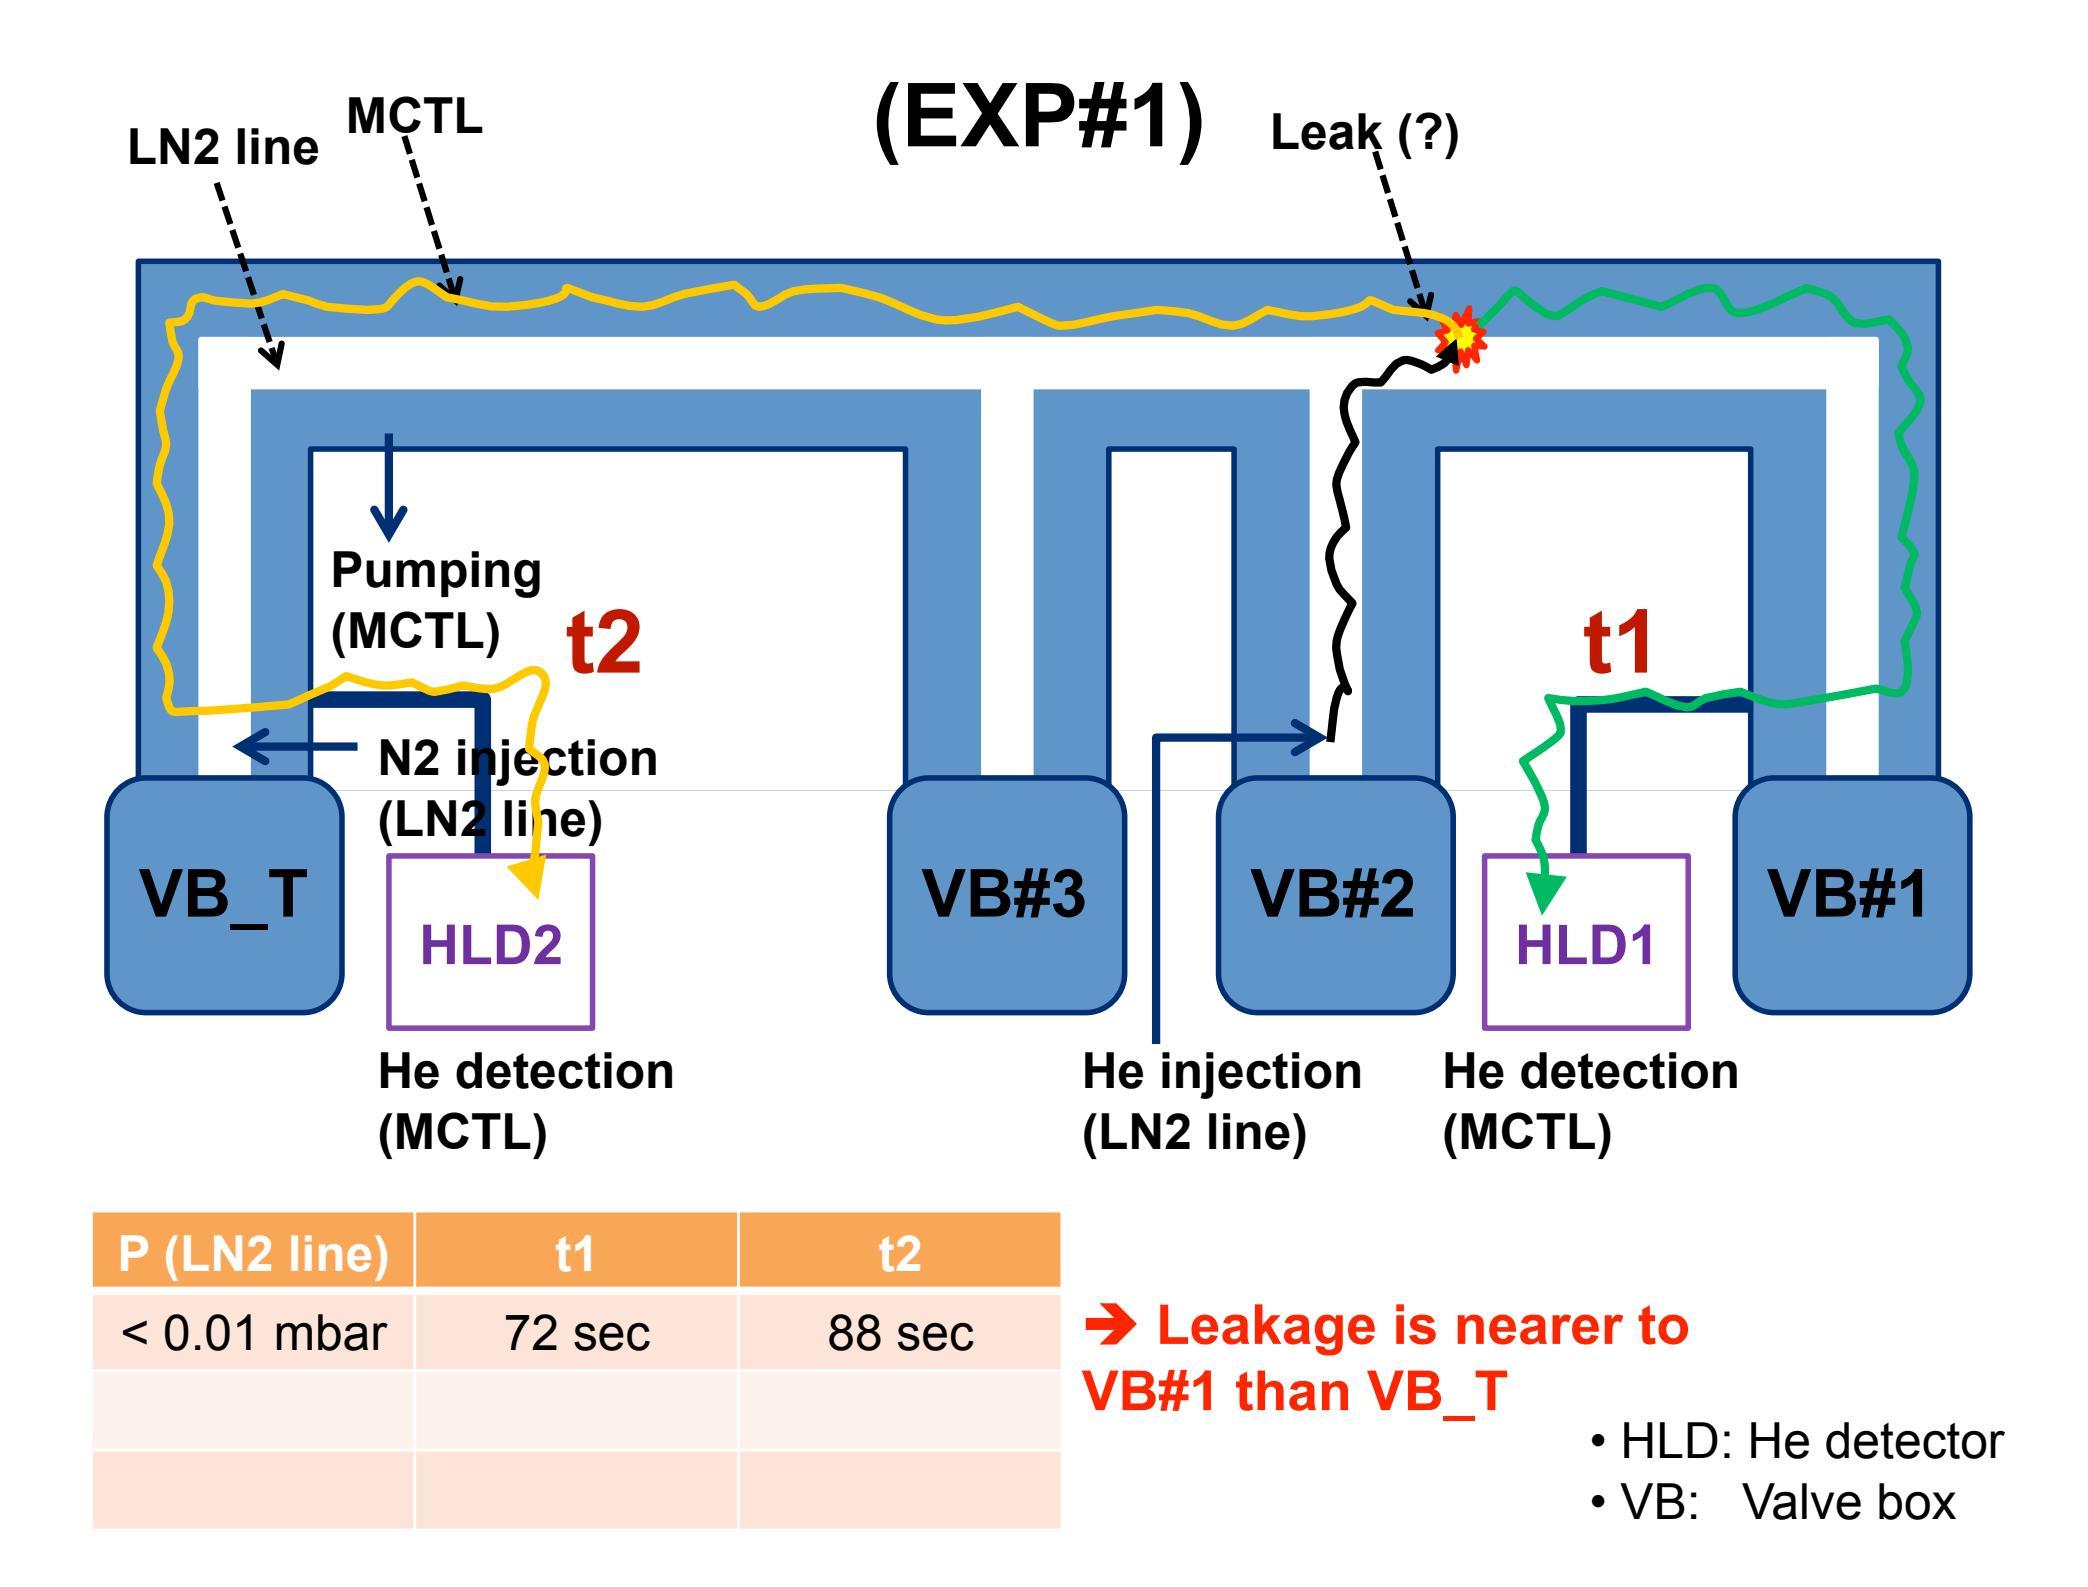
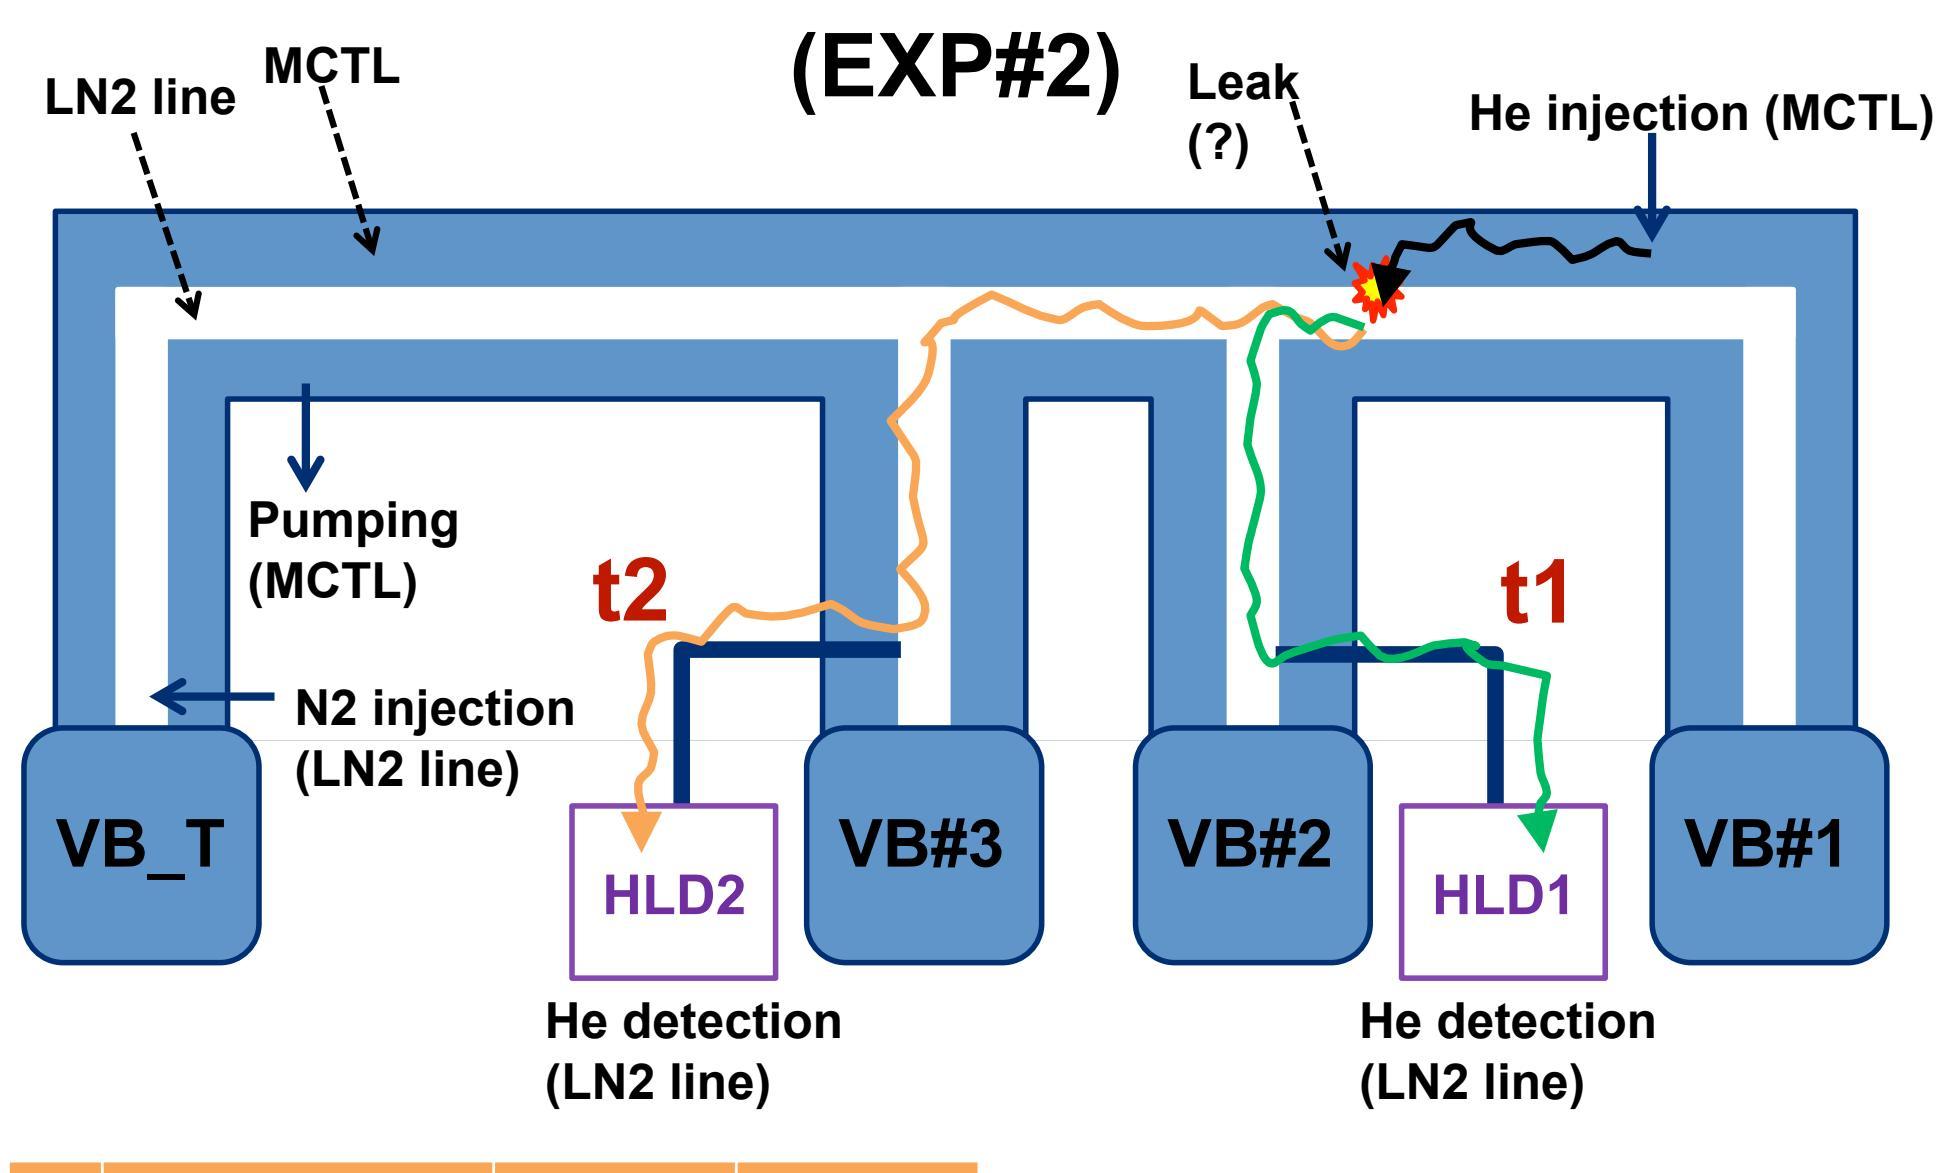
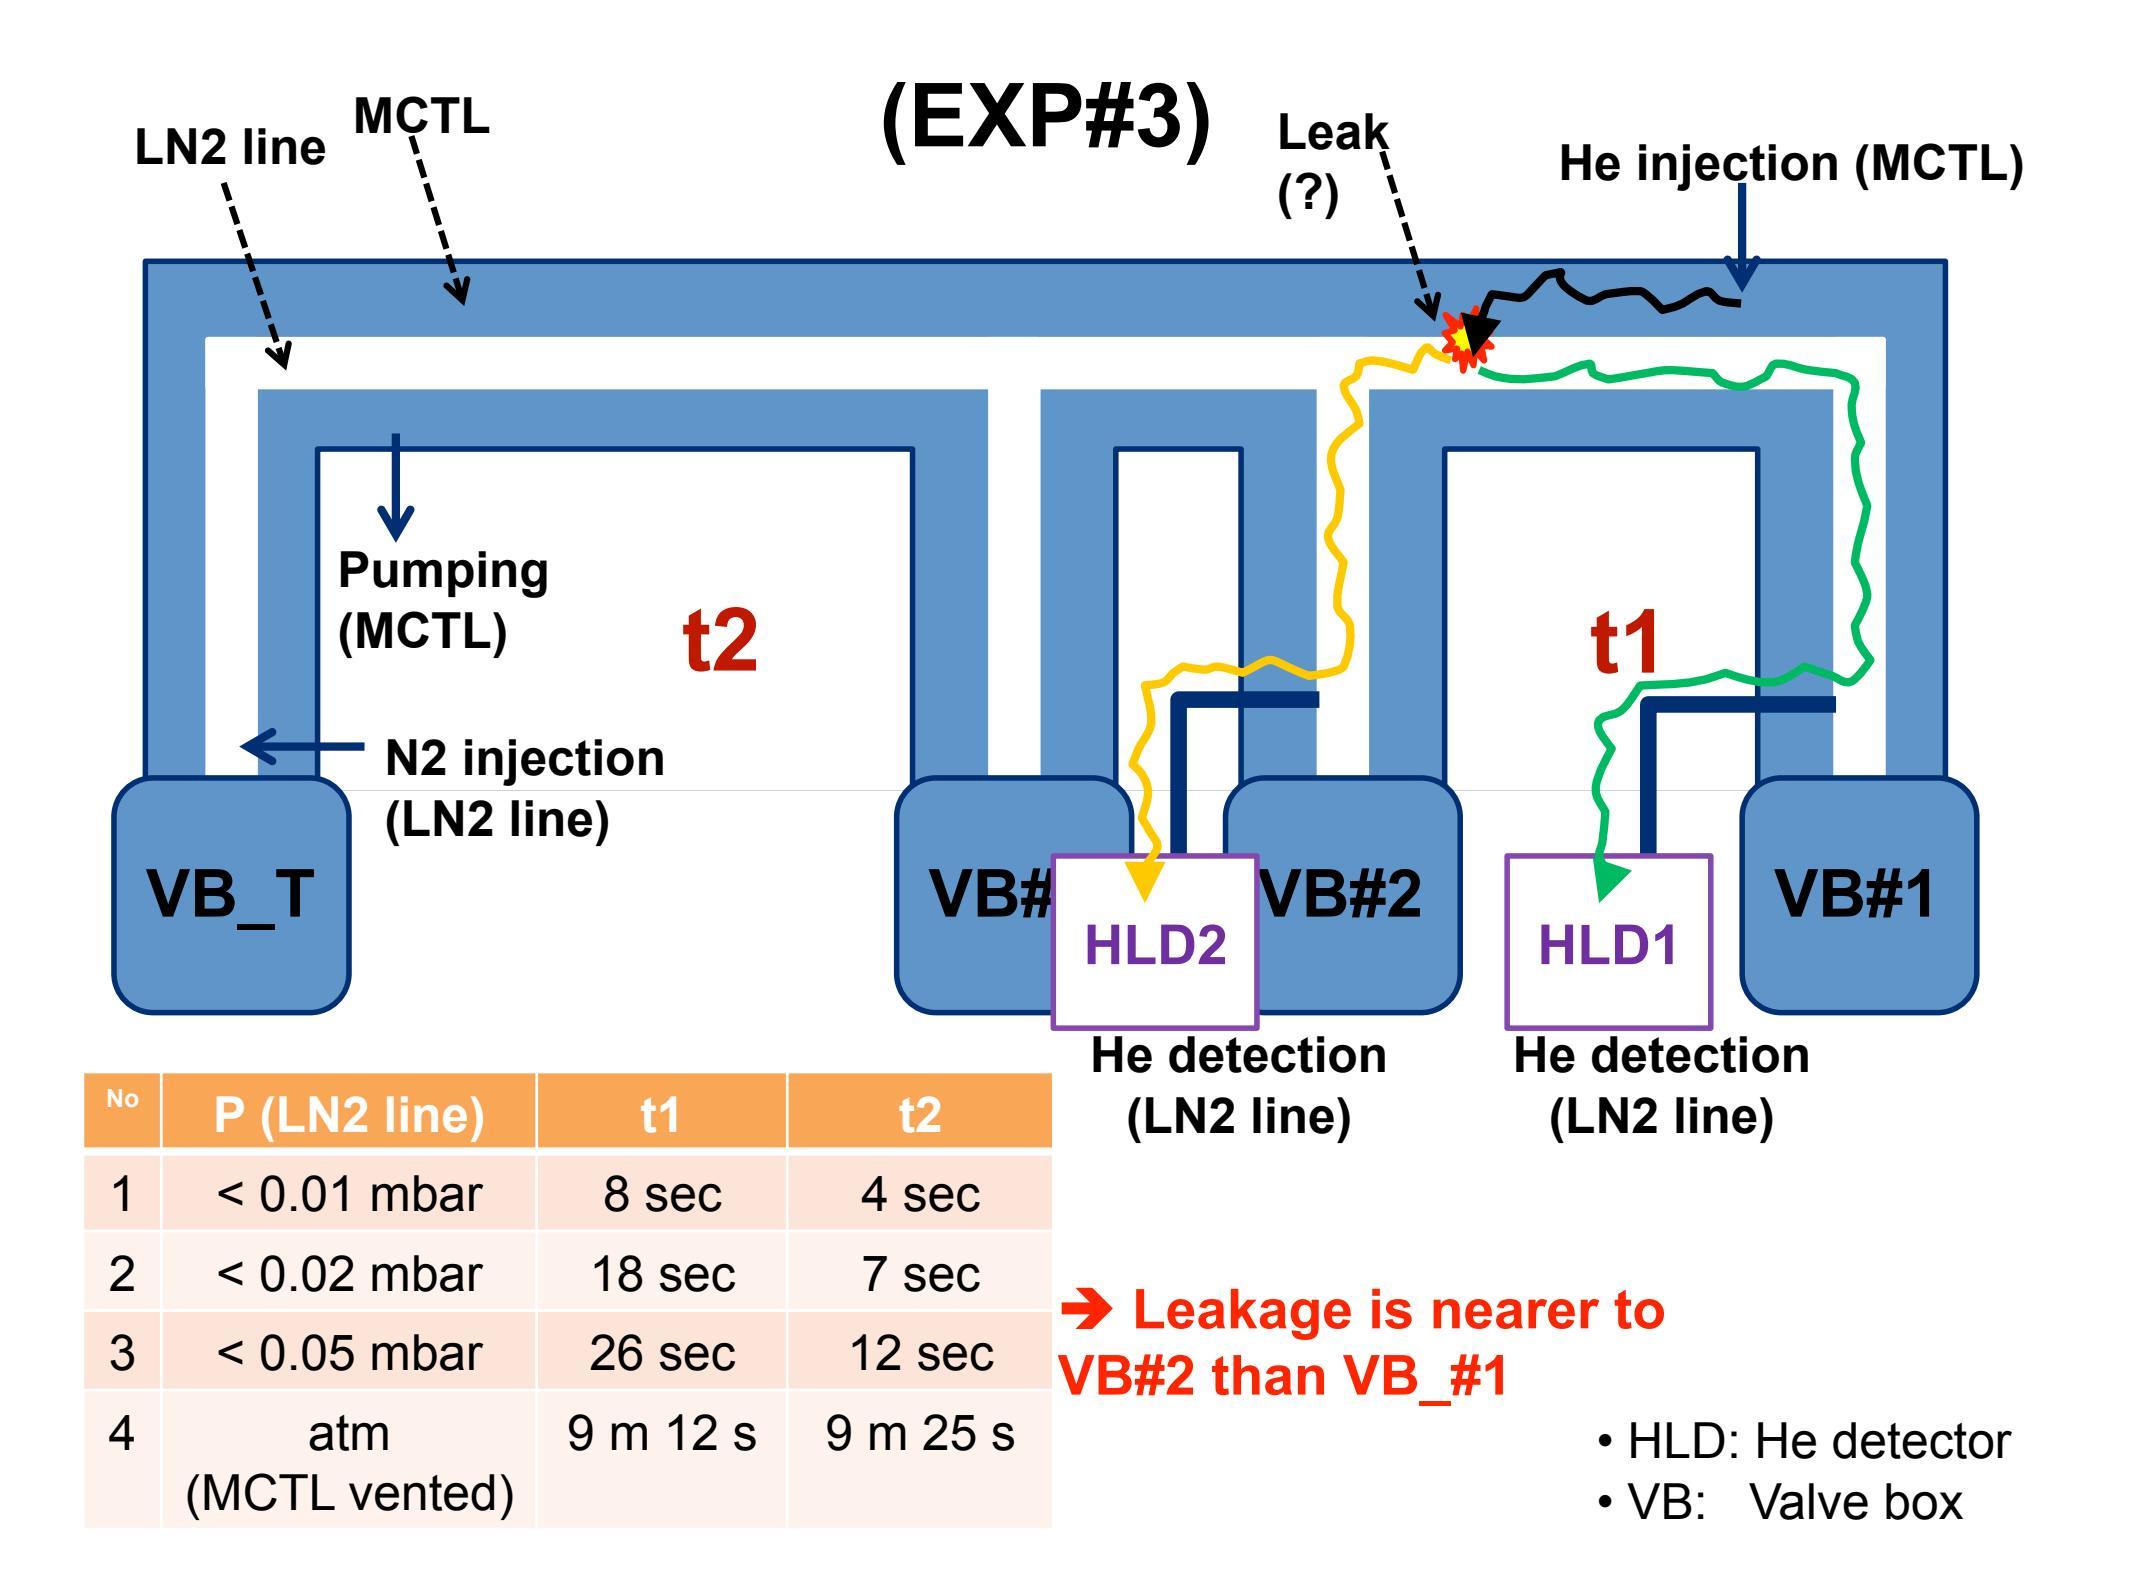
Leak Detecting Procedure

No	P (LN2 line)	t1	t2	
1	< 0.01 mbar	16 sec	16 sec	
2	< 0.05 mbar	12 sec	20 sec	 Leakage is nearer to VB#2 than VB_#3 HLD: He detector VB: Valve box
3	< 0.1 mbar	13 sec	35 sec

- 1. Place two He leak detectors(HLDs) on the LN2 line and inject He g as into MCTL pipe or vice versa.
- 2. Check the He detecting time between two HLDs.
- 3. The leakage is nearer to the HLD which detects He first. (If the pre ssure in the LN2 pipe is uniform, then the He diffusion velocities ar e equivalent)
- 4. If the time difference is negligible, inject little amount of N2 gas into the LN2 line to increase the He diffusion time in the line. Then che ck the time difference again.
- 5. Change the N2 background pressure in the LN2 line to confirm the He arrival time delay.
- 6. If the pressure of LN2 line is too high then we have severe pressur e gradient in the pipe (because two HLDs are pumping at different places). In this condition the He diffusion velocity is not uniform. Th is cause an error.

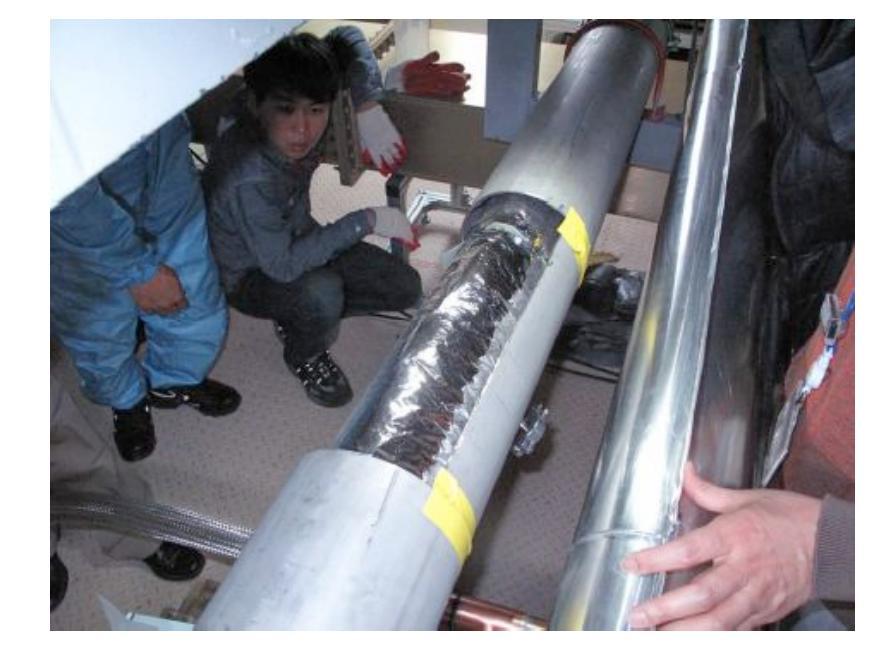
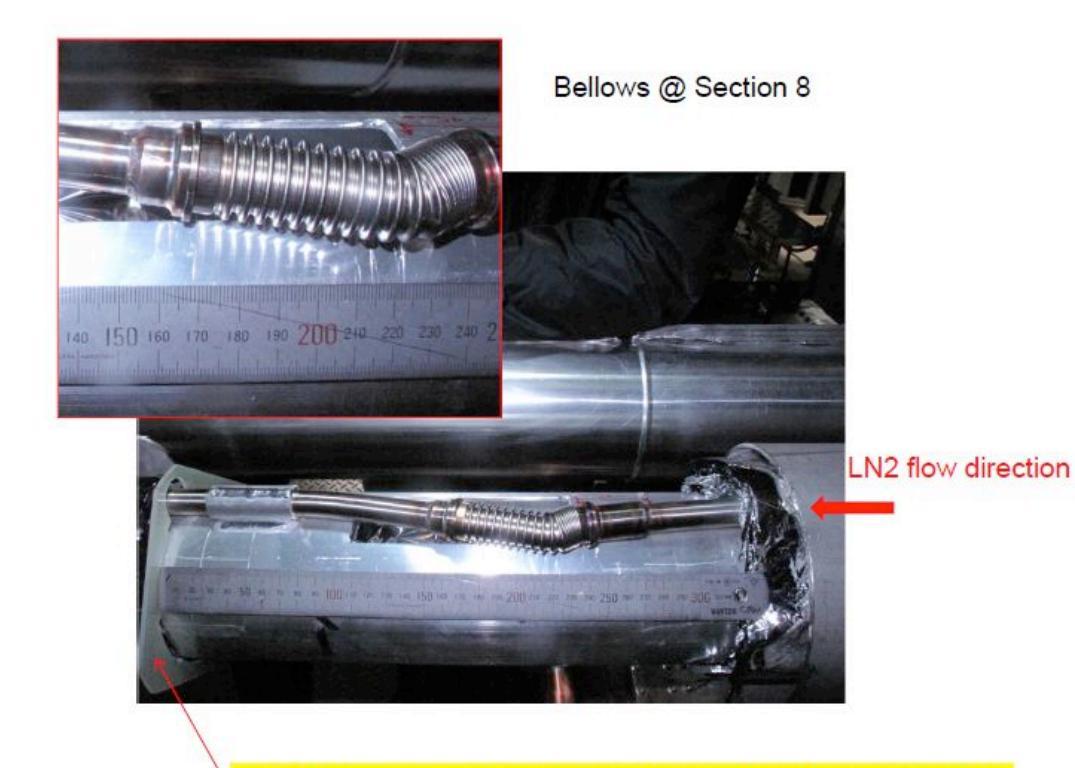
Damaged bellow

LN2 line spacer must be at upstream of LN2 flow, but it is at downstream.
