Design and Operation Experience o f PLS-II Vacuum System

2015.01.25 Taekyun Ha, Chongdo Park

On behalf of Vacuum Group Pohang Accelerator Laboratory

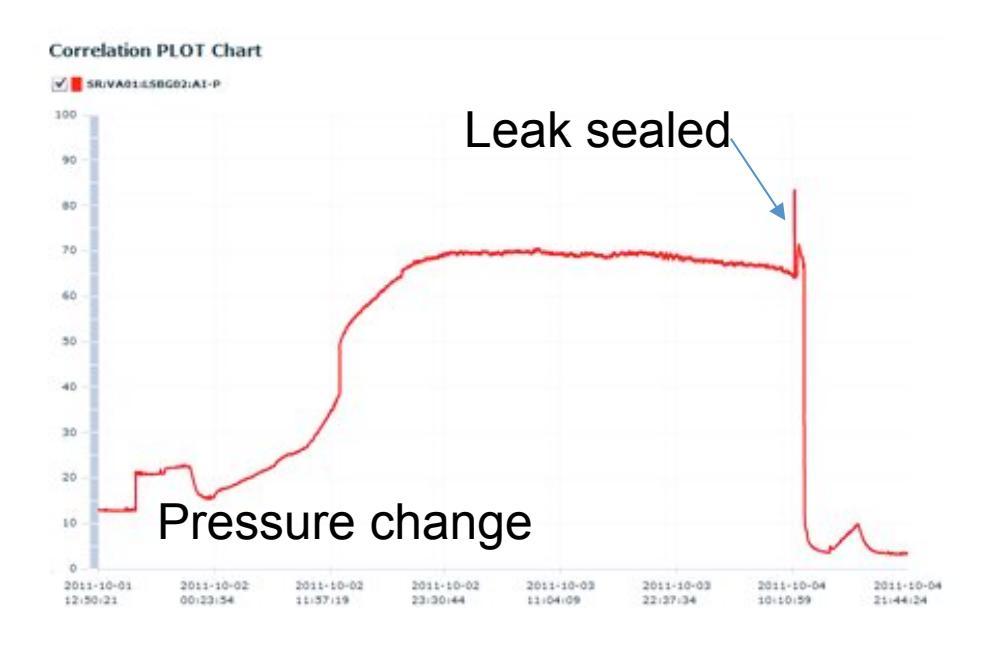
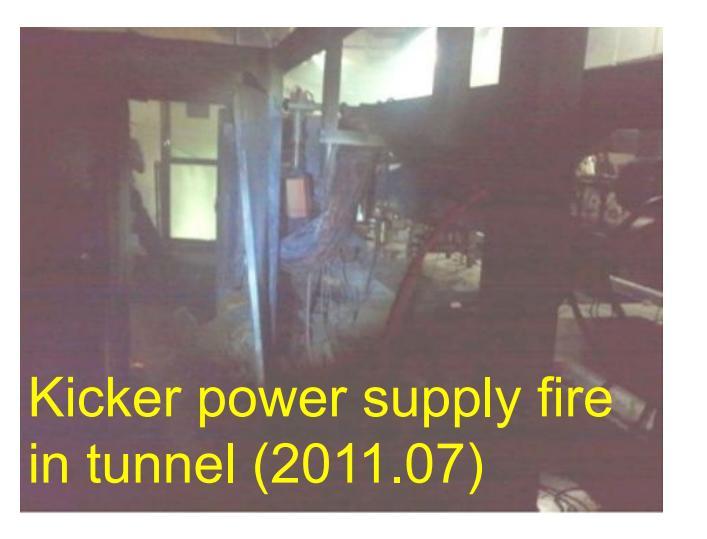
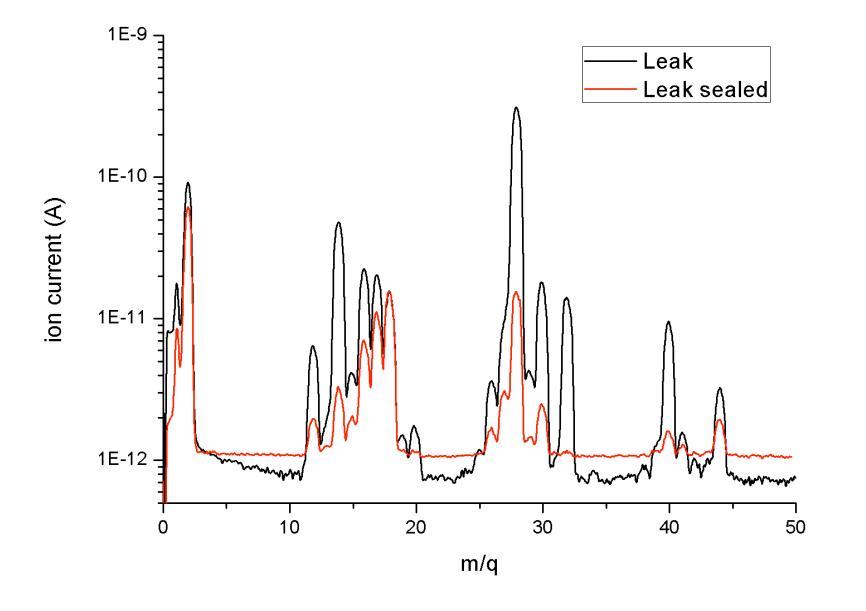
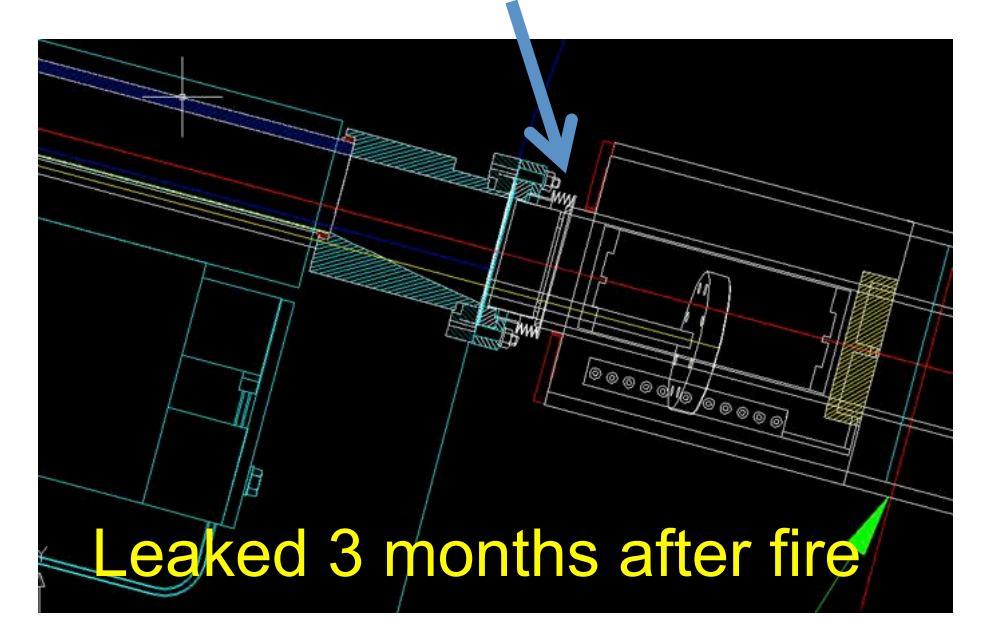
Leakage in injection section (after fire)

Weld join of bellows was corroded by particles produced during fire

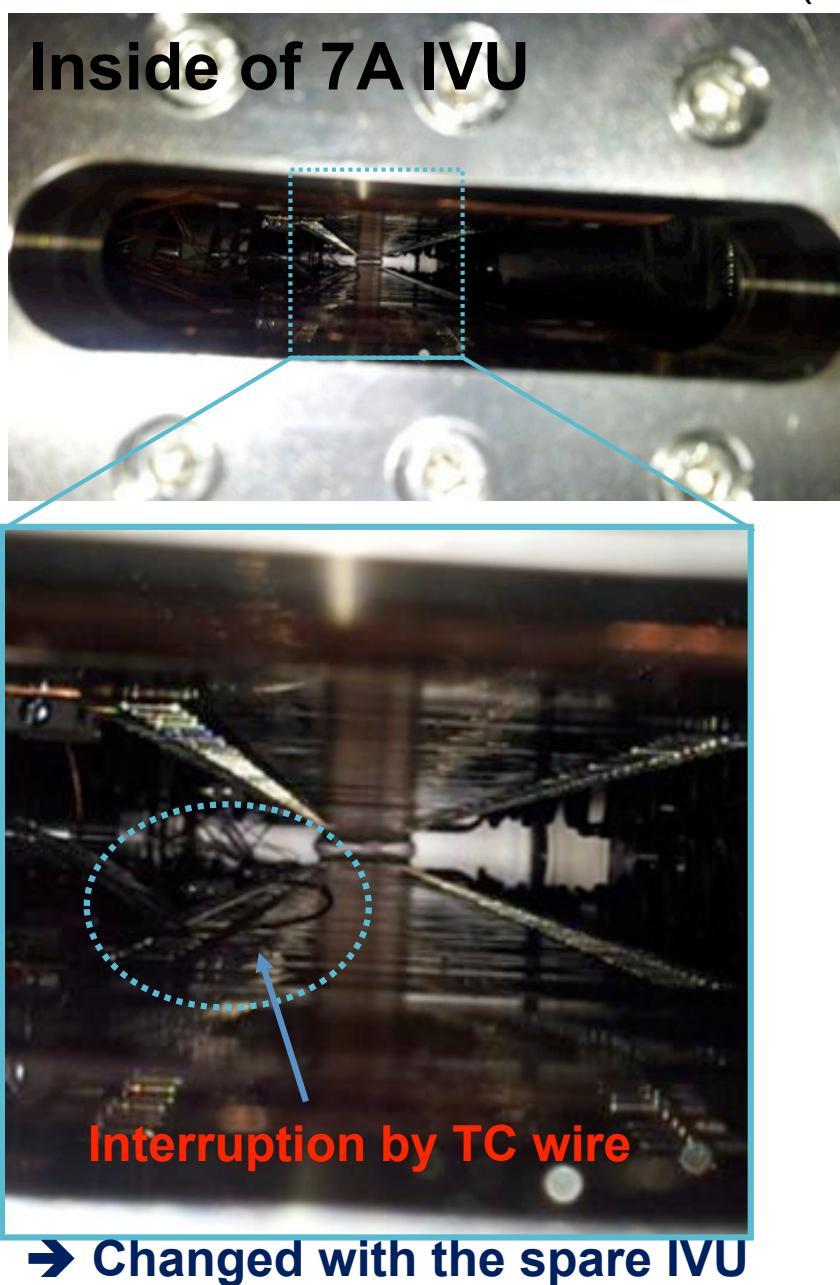
Abnormal pressure in an IVU

Pressure Distribution along the Ring 1E-6 🚽 90 mA (beam dose of 2.5 AH) 0 mA 1E-7 1E-8 P (torr) 1E-1E-10 1E-11 #01 #03 #05 #07['] #09 #11 #12 Position (cell number) Pressure high at 7A IVU 7A (ADC) 7C (SFA) 1E-6 pressure (torr) 1E-7 -1E-8 -1E-9 -2011-10-09 18:53:34 2011-10-15 13:46:57 2011-10-21 08:42:45 2011-10-27 03:36:42 time

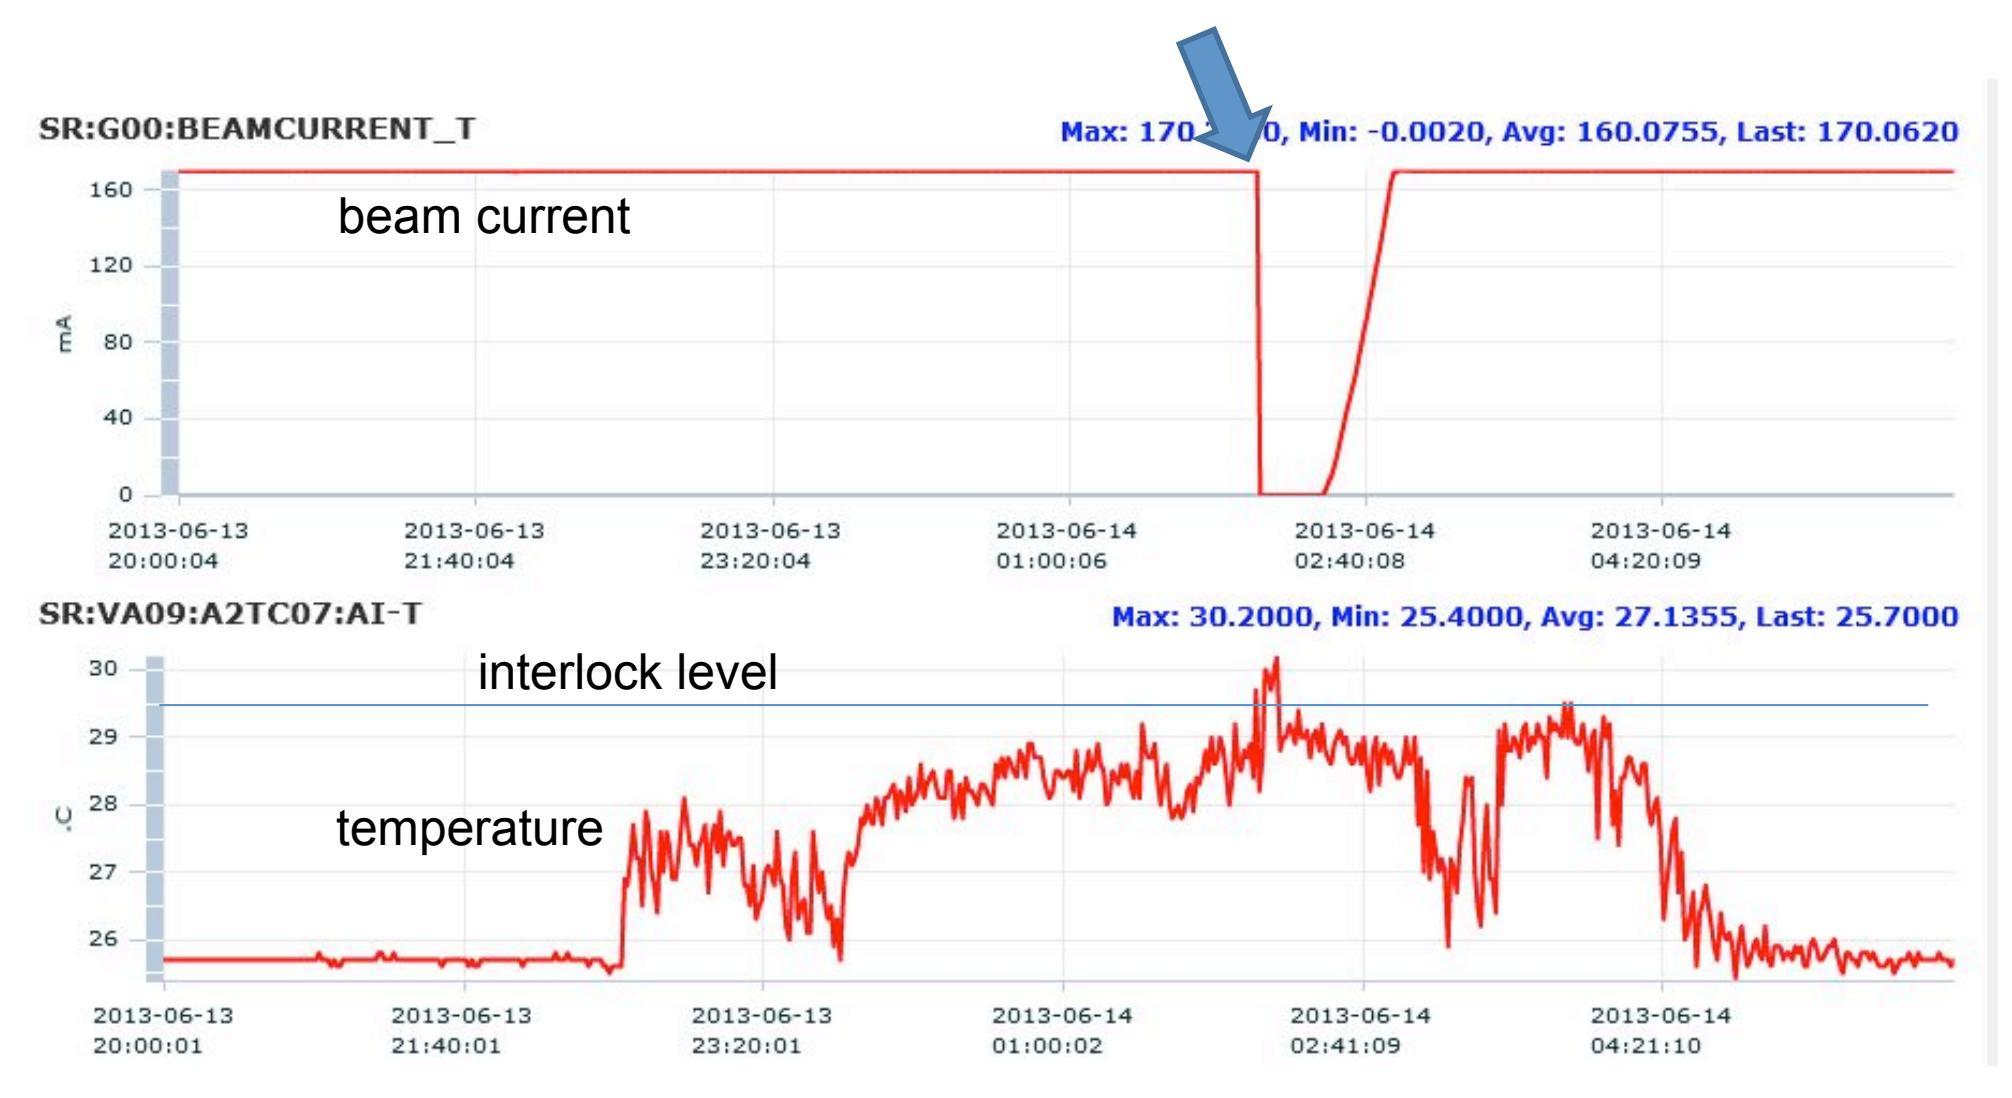
Thermocouple malfunction

Beam was dumped due to the malfunction of a thermocouple out of 720 ea

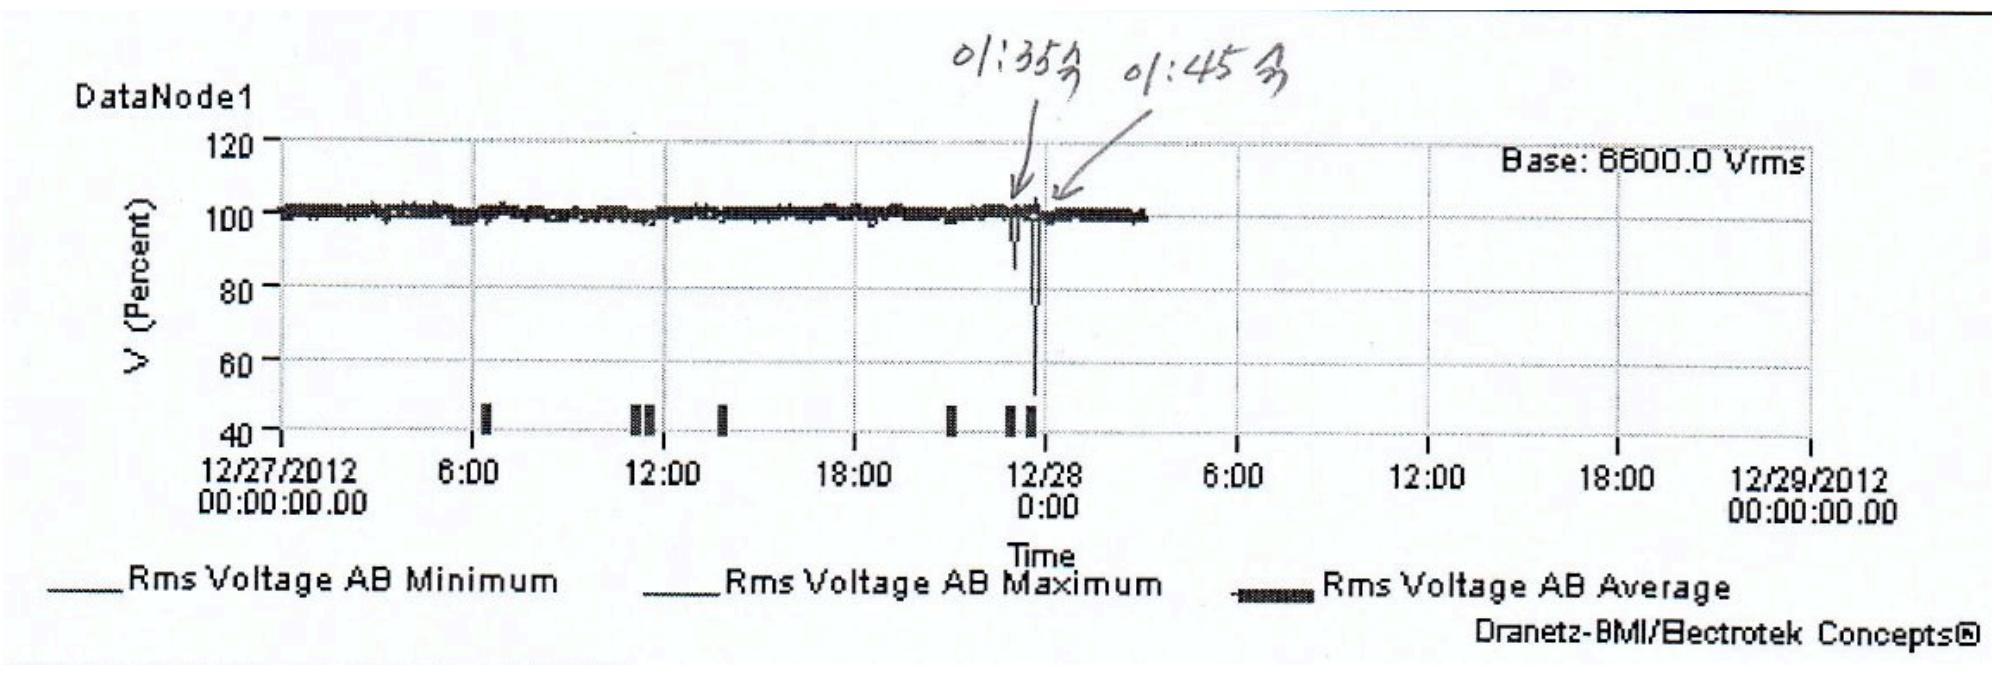
Gauge controller malfunction due to sag

Old Ion gauge controller (GP307)

Instantaneous voltage sag → gauge controller emission off →

Analog output sent 10 V signal -> Machine Interlock System triggered

→Gate valve closed → beam dump

(The controller being in trouble was changed then it became O.K.)
