Design and Operation Experience o f PLS-II Vacuum System

2015.01.25 Taekyun Ha, Chongdo Park

On behalf of Vacuum Group Pohang Accelerator Laboratory

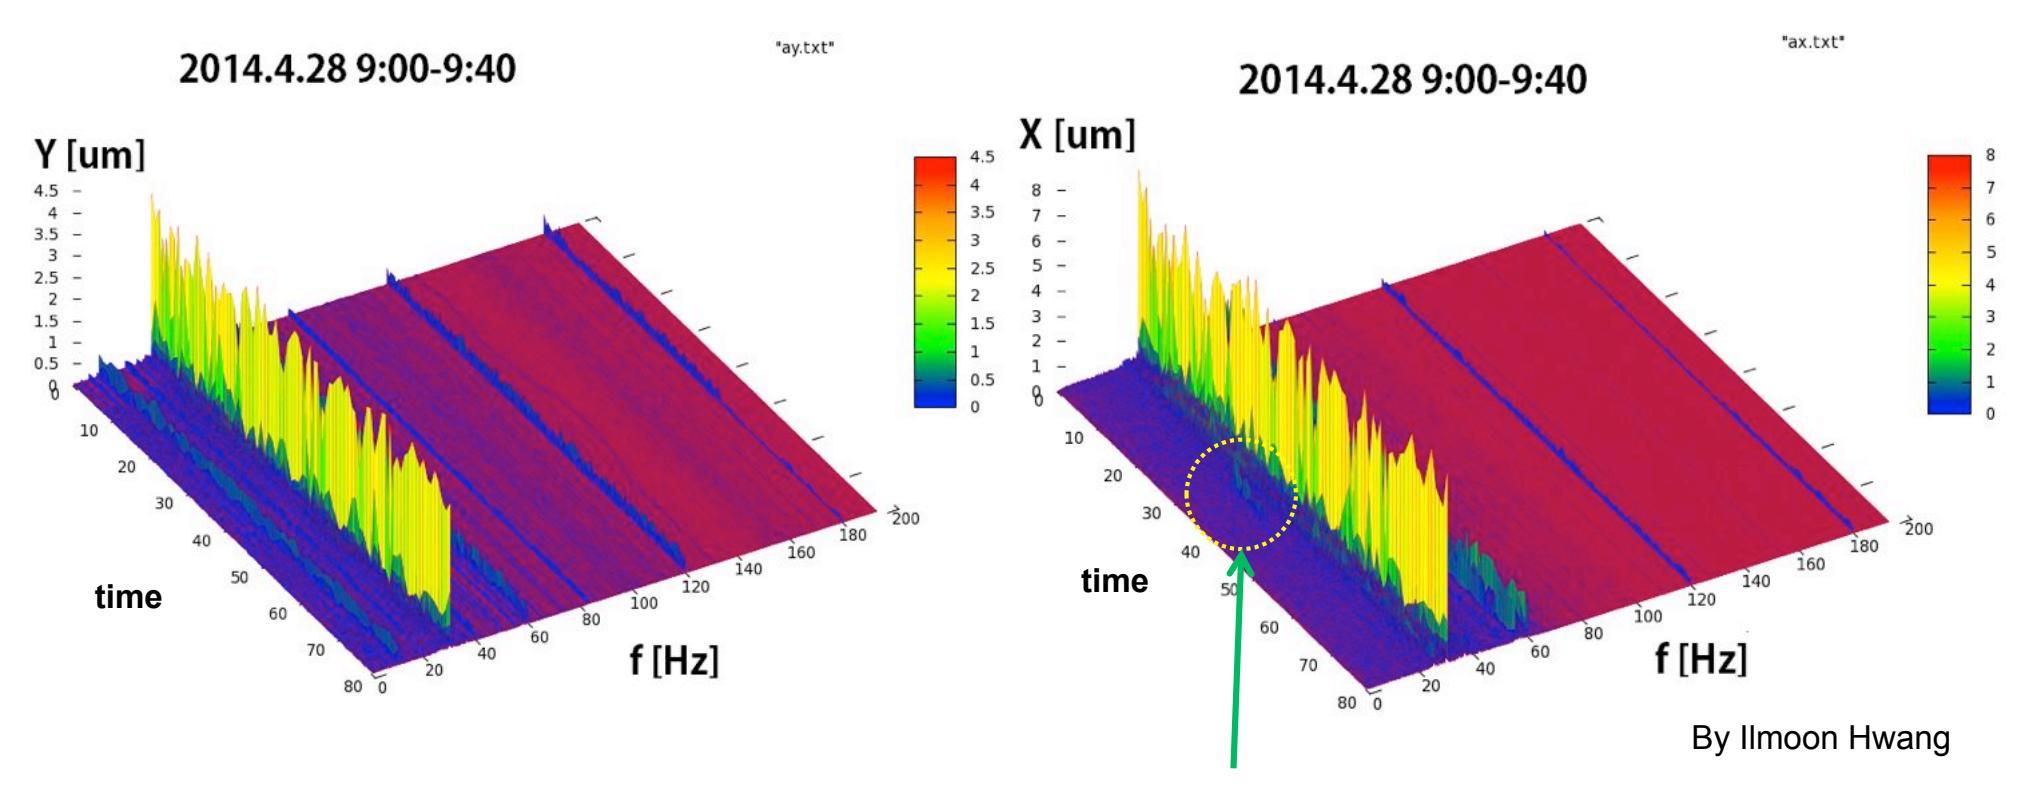
Vibration monitored by electron BPM

(Air fan of experimental hall on&off)

Air fan on (20 Hz peak is appeared)

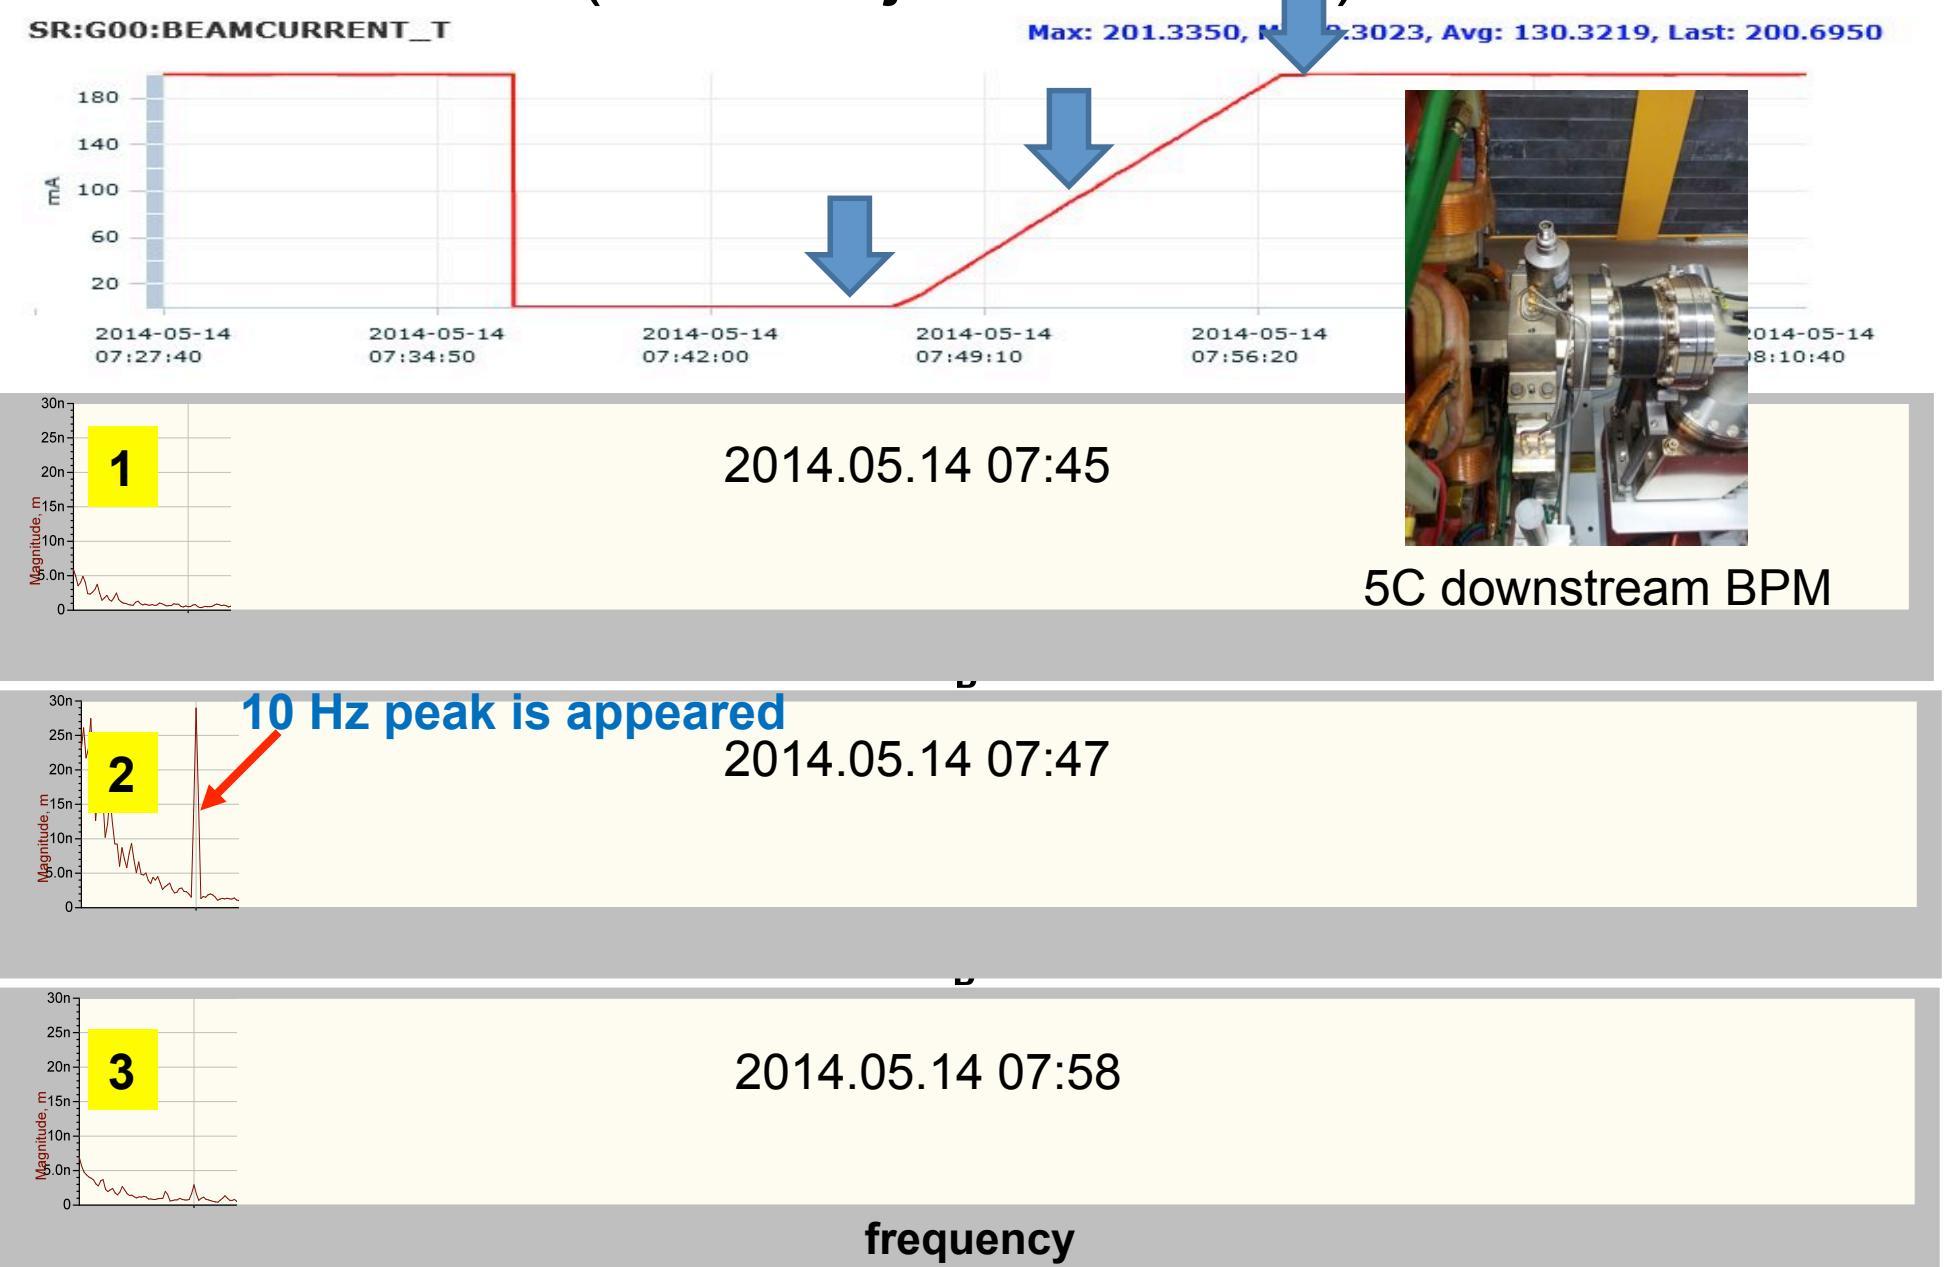
Vibration during beam injection

(10 Hz injection kicker)

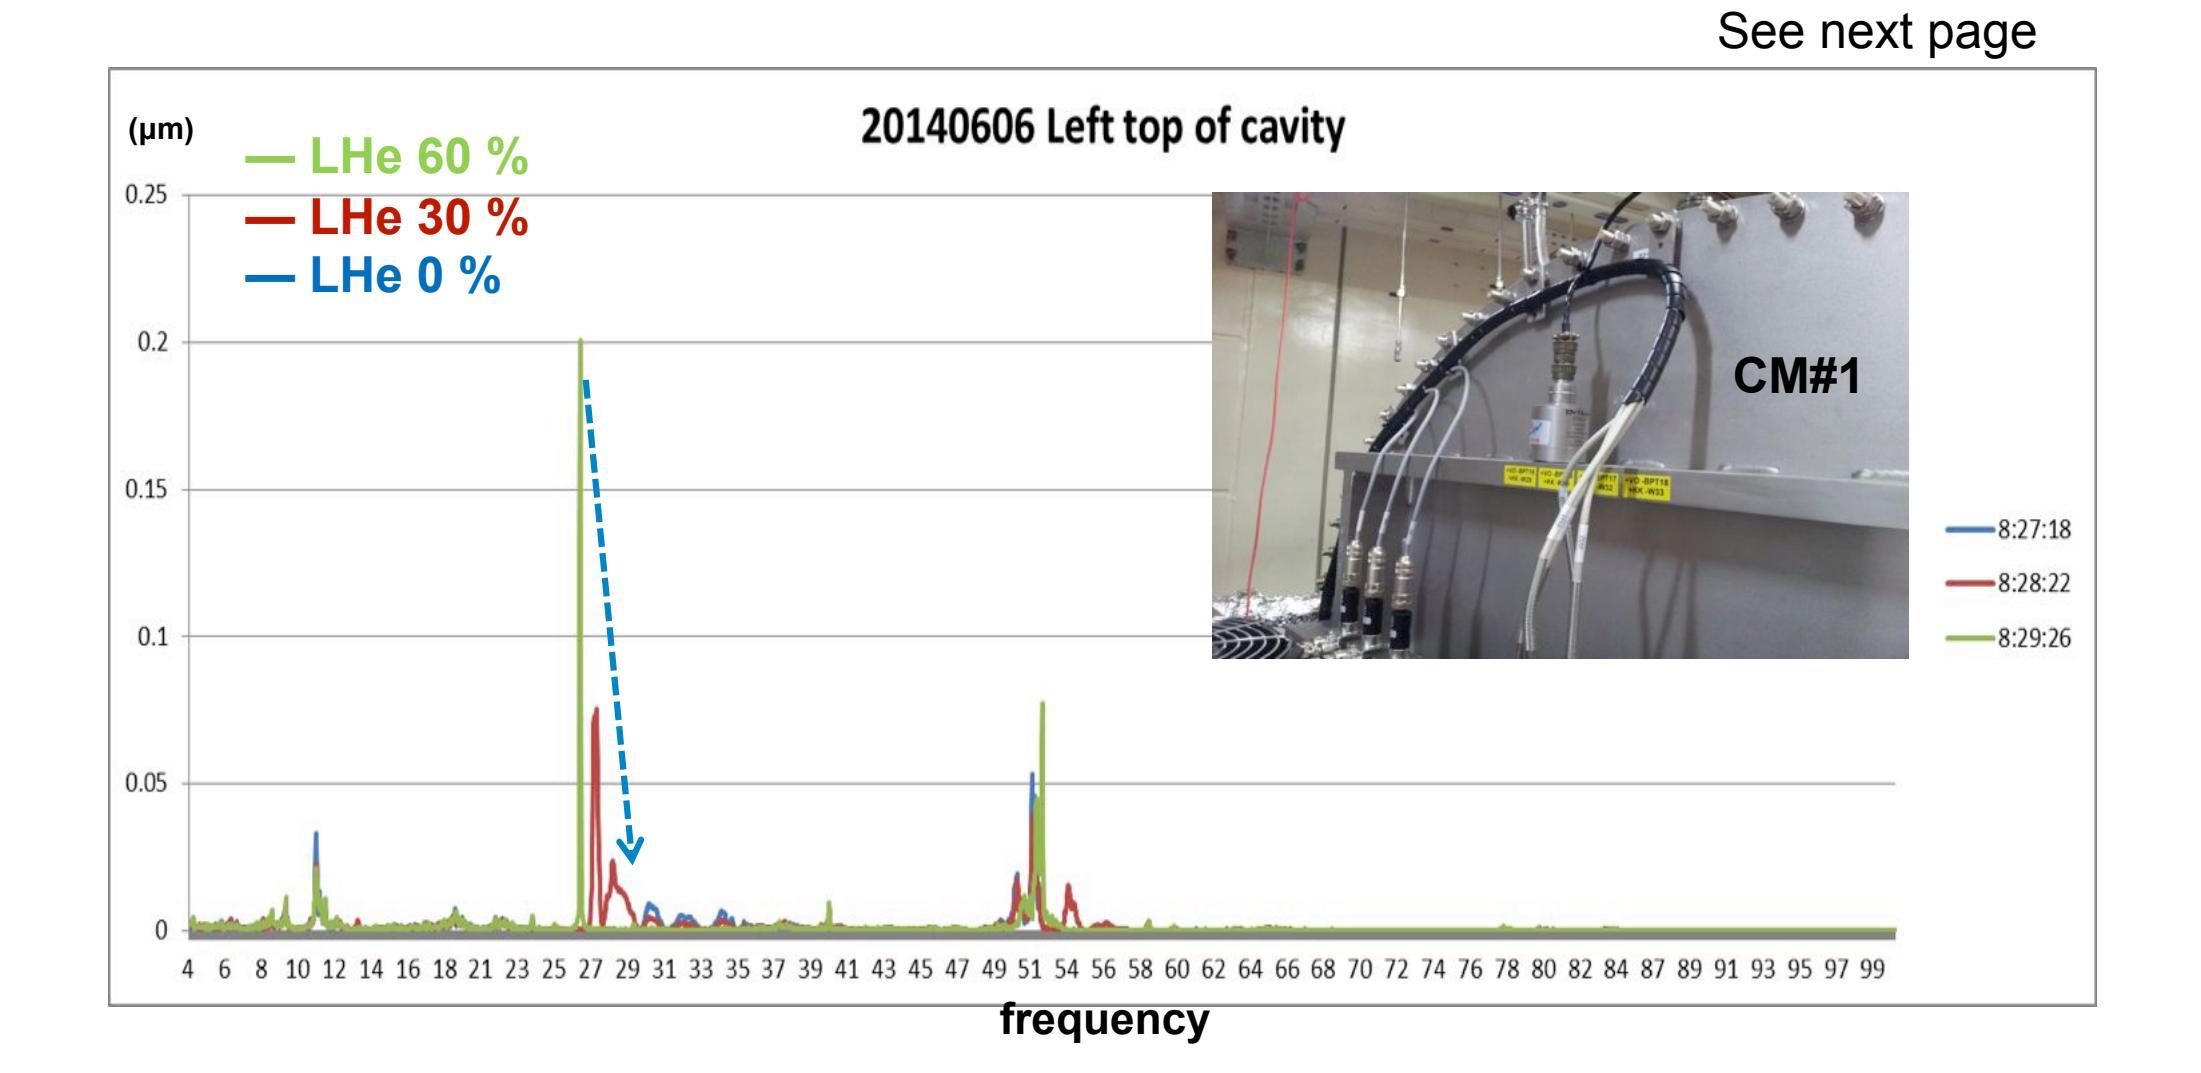
Vibration of super conducting RF cryo-module

(during liquid He drain)

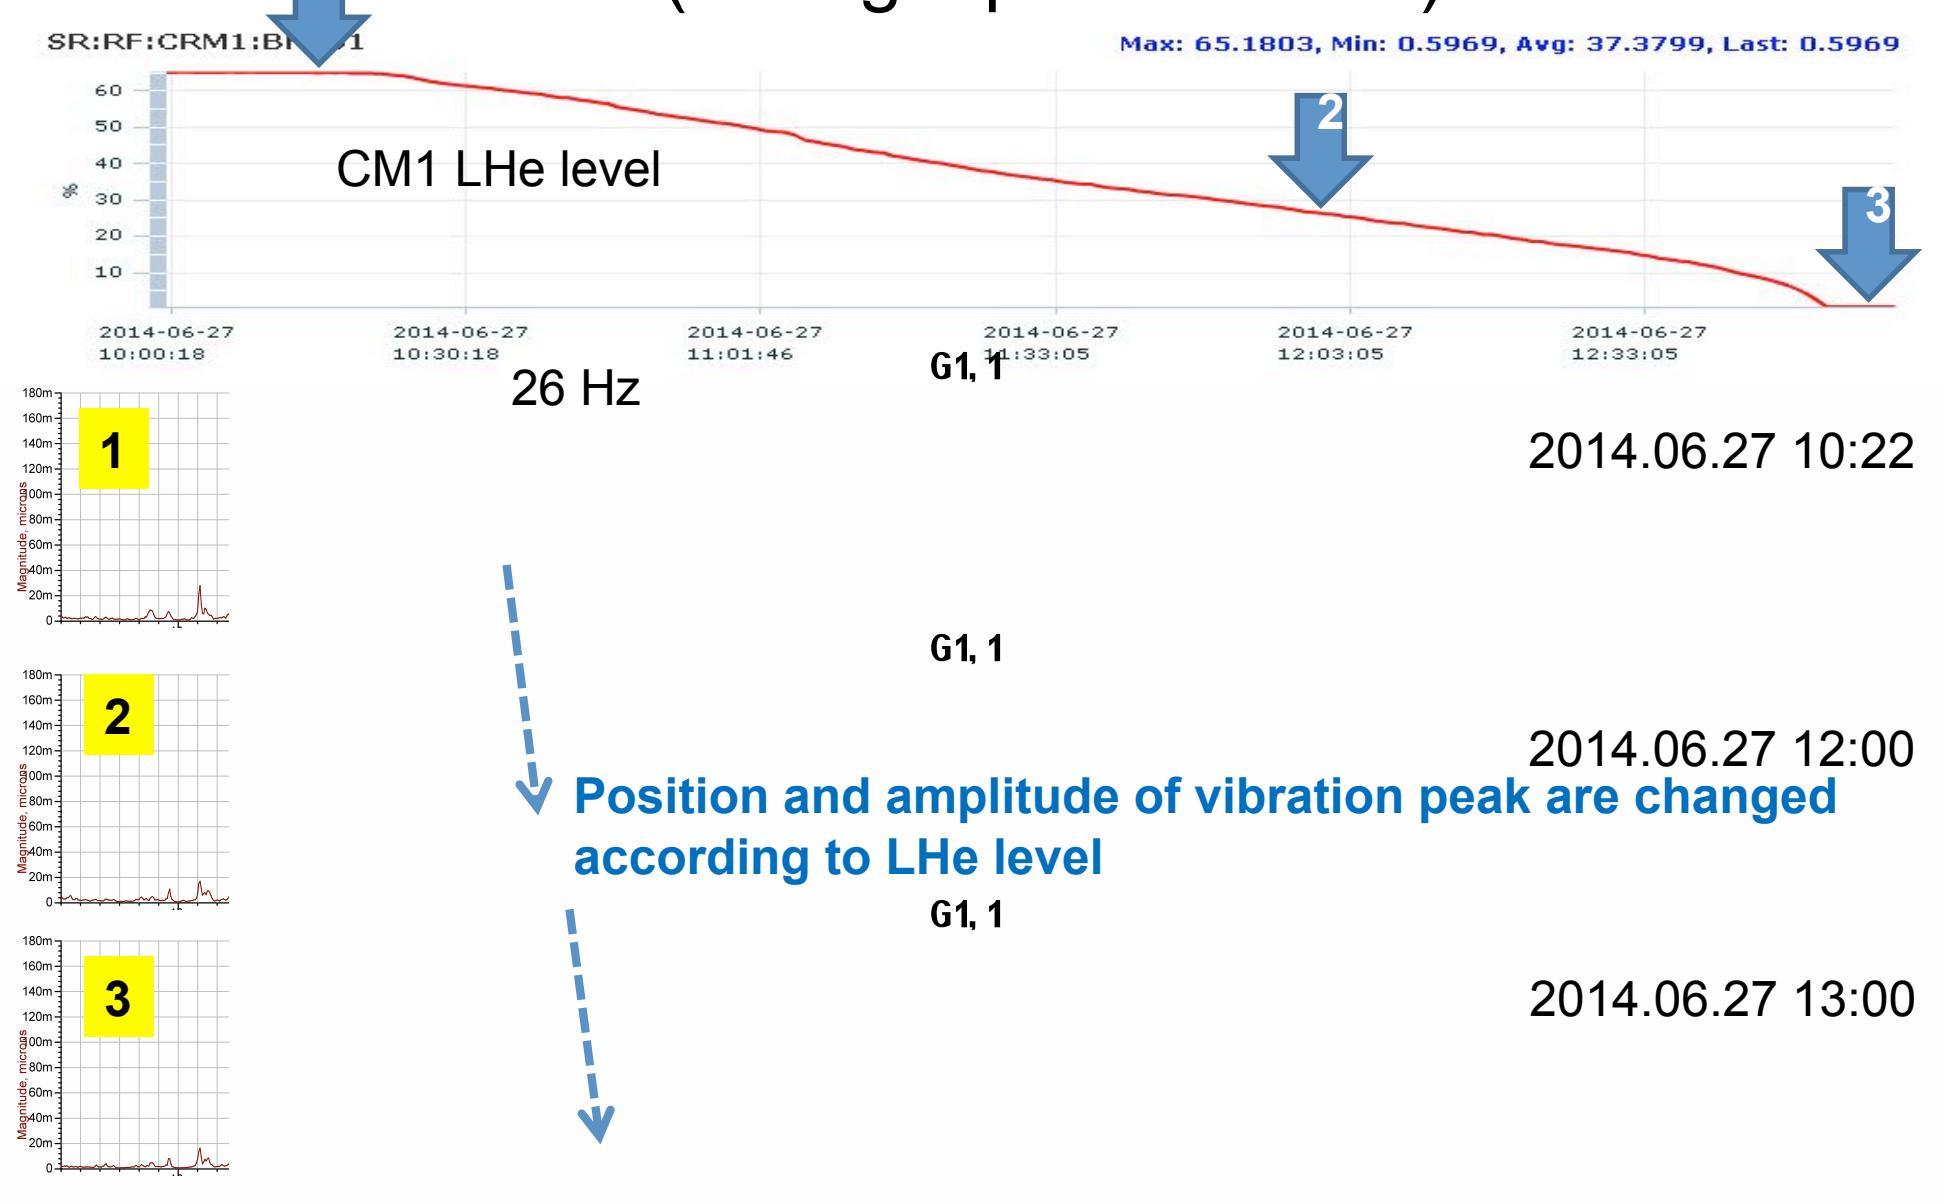
Vibration of super conducting RF cryo-module

(during liquid He drain)

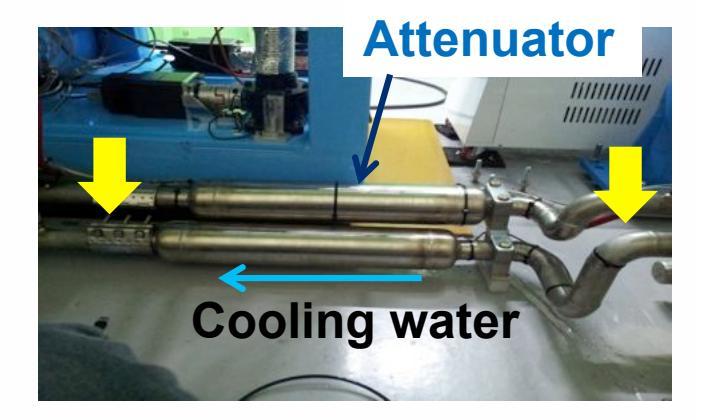
Vibration of cooling water pipe attenuator

(before and after attenuator passage)

After passing the attenuator

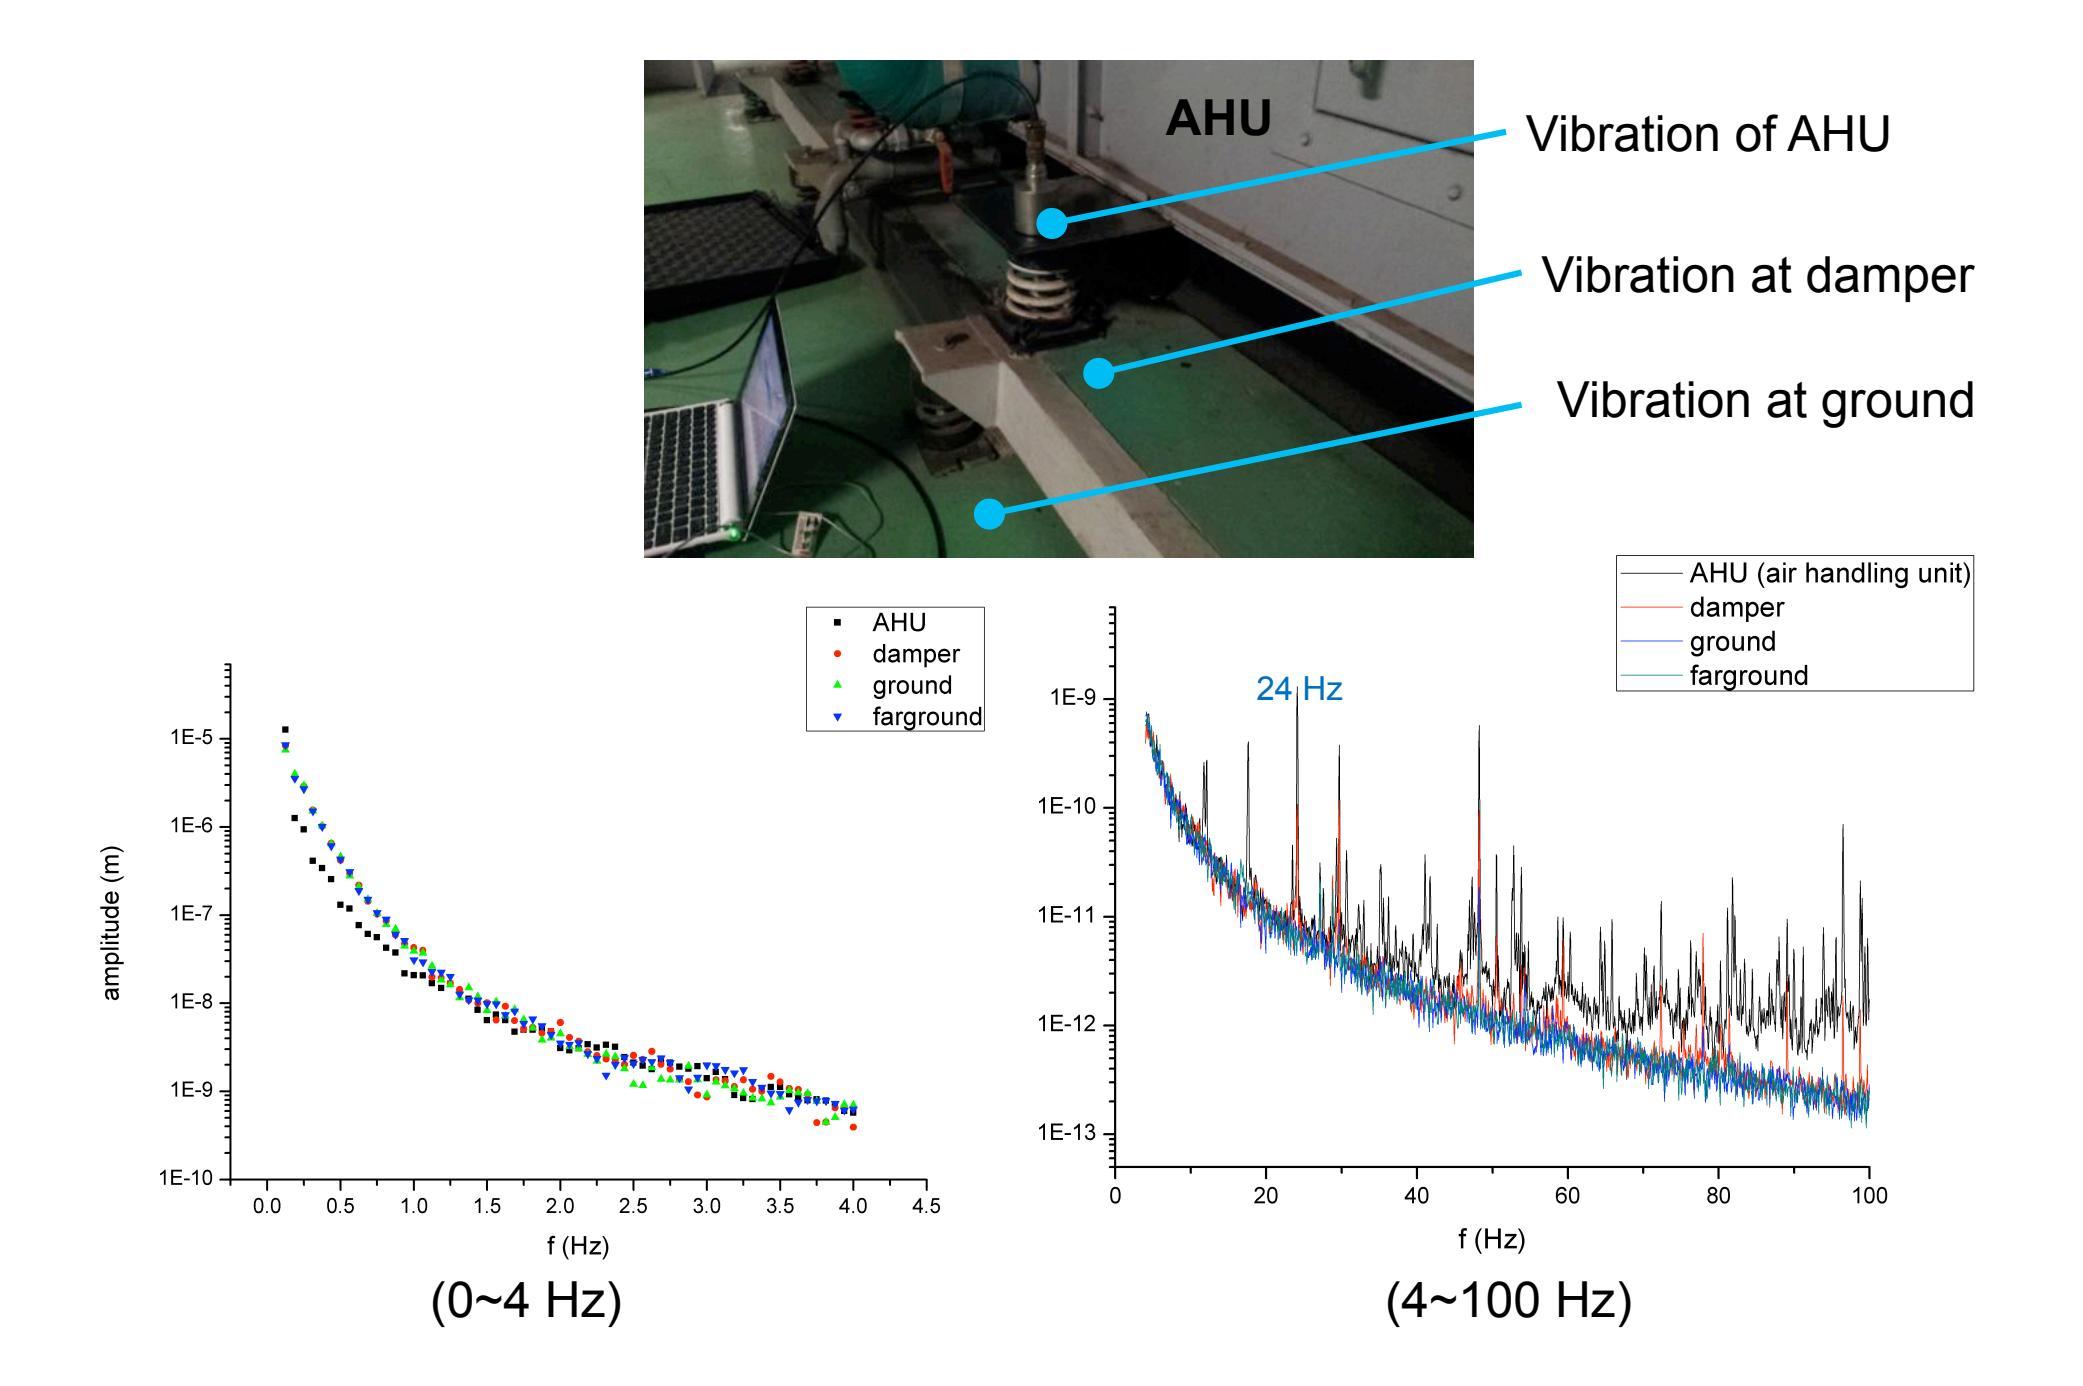
Vibration due to Air Handling Unit (AHU)

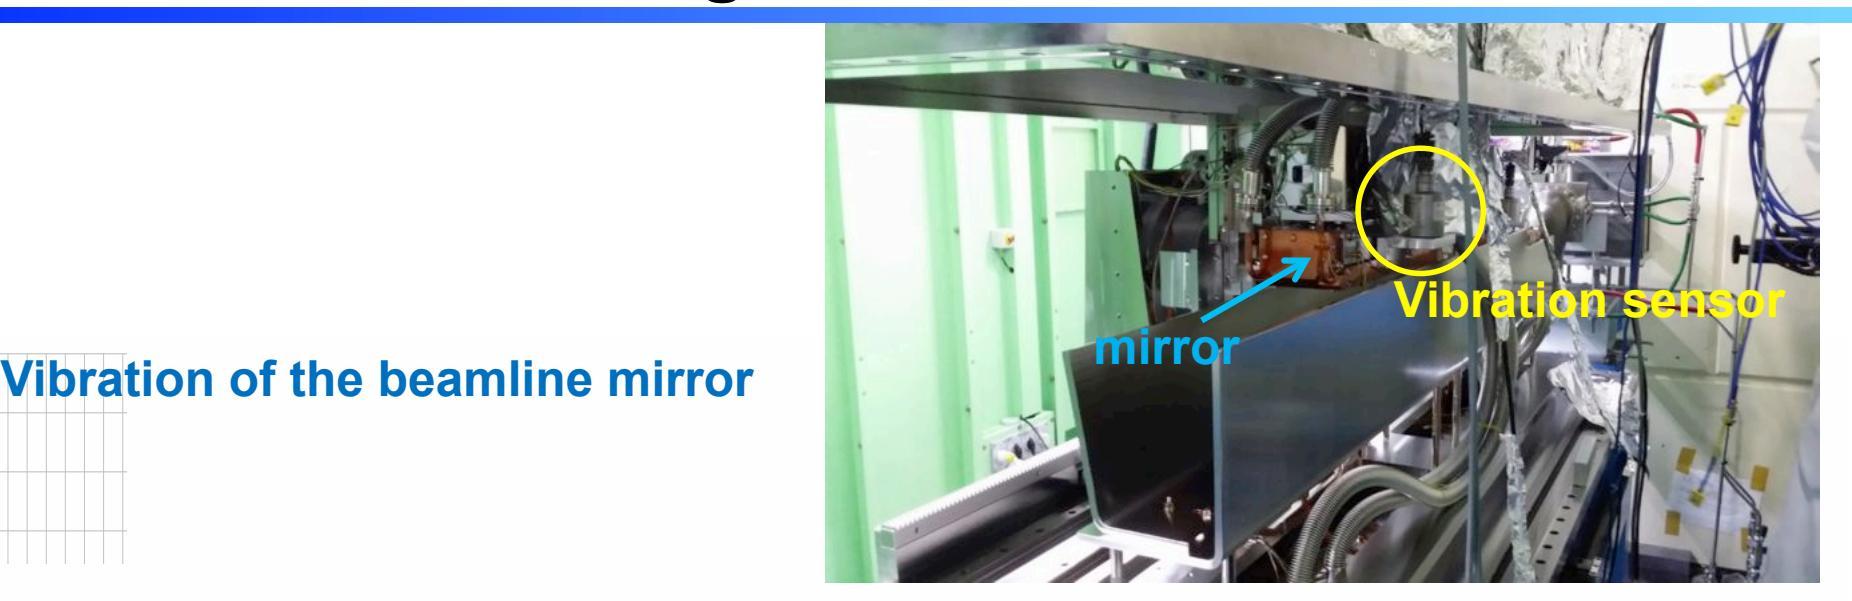
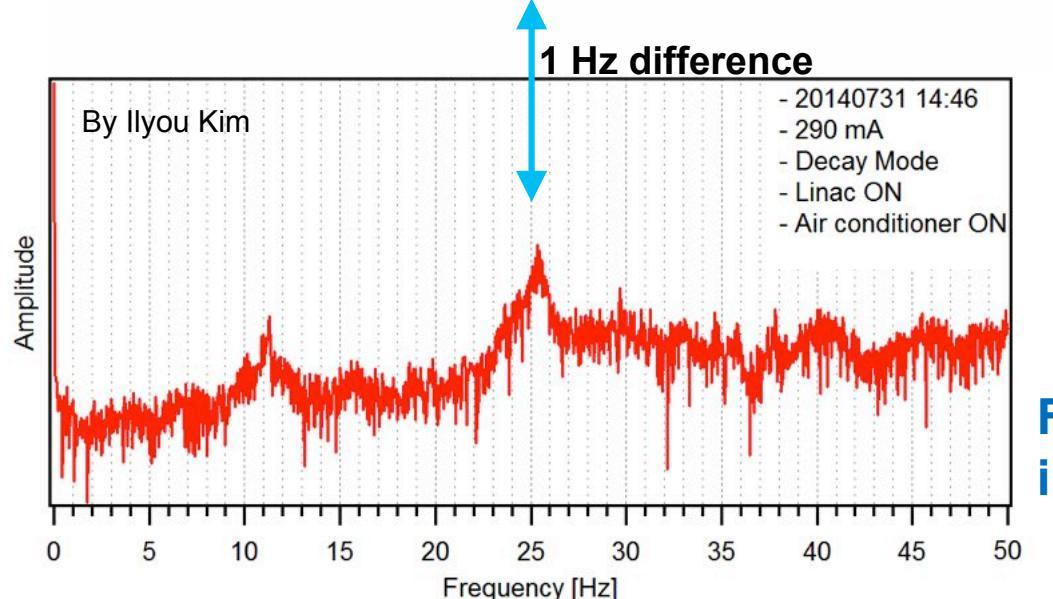
Beamline image vibration vs. mirror

Frequency analysis from measured image data in 6C image beamline

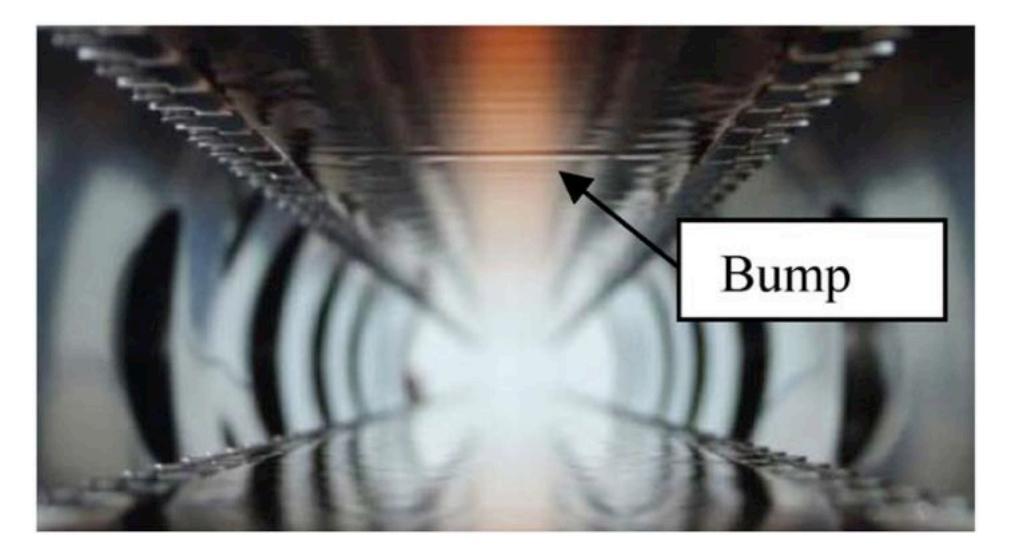
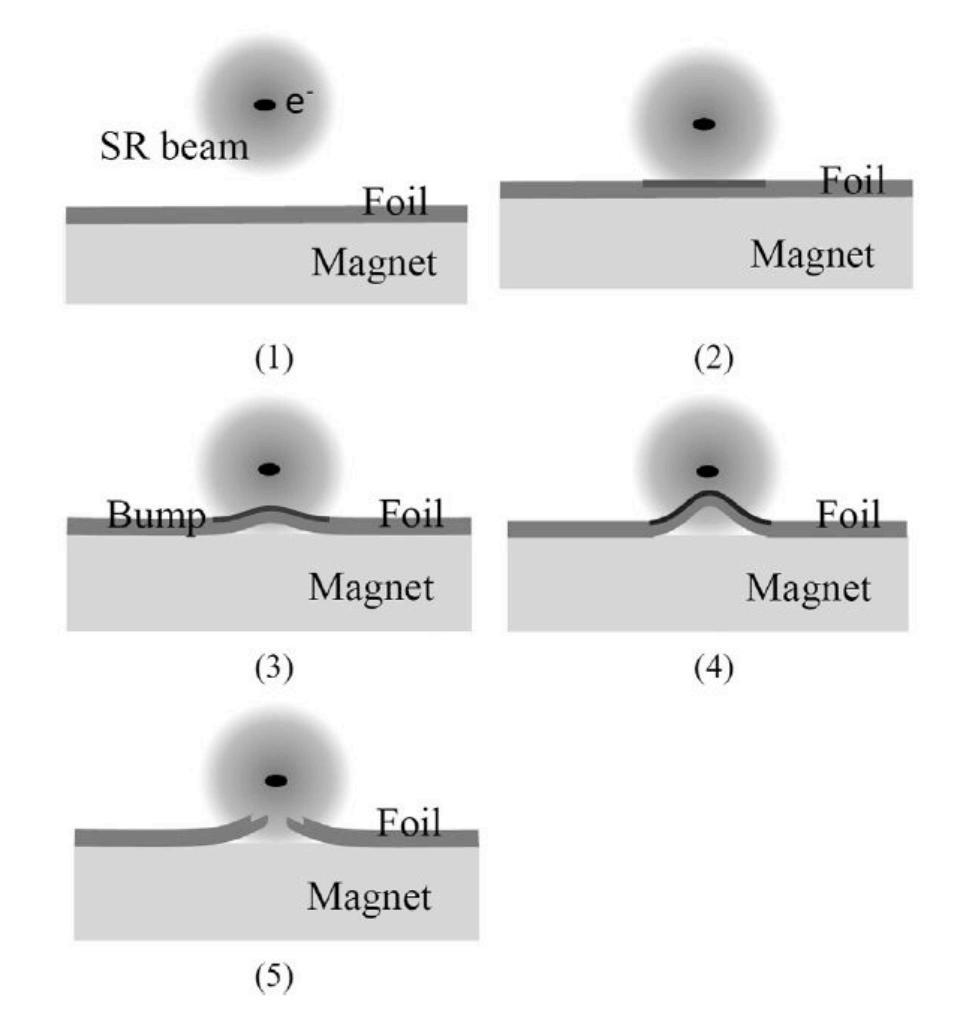
IVU trouble in NSRRC

Bump on the magnet foil after baking (Before operation)

Scenario of an avalanche meltdown due to a beam-induced heat load

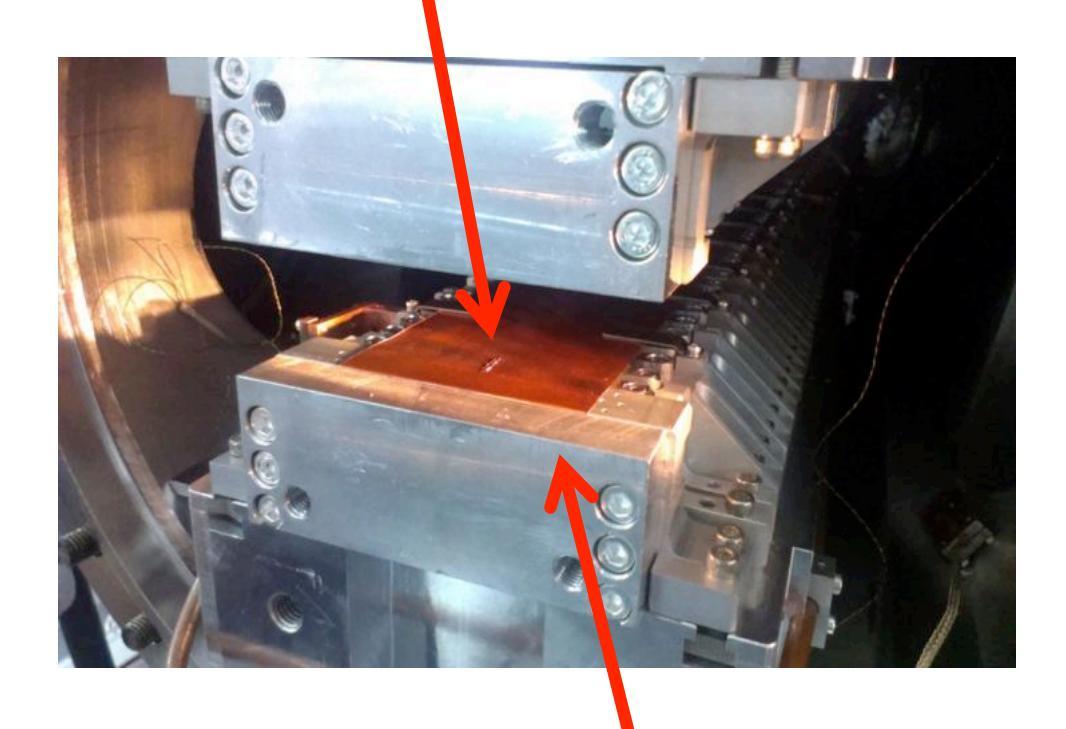
IVU trouble in SSRF

Because the copper foil drum up, this scratch may be cut by beam

Reinstalled the block to make the copper foil smooth

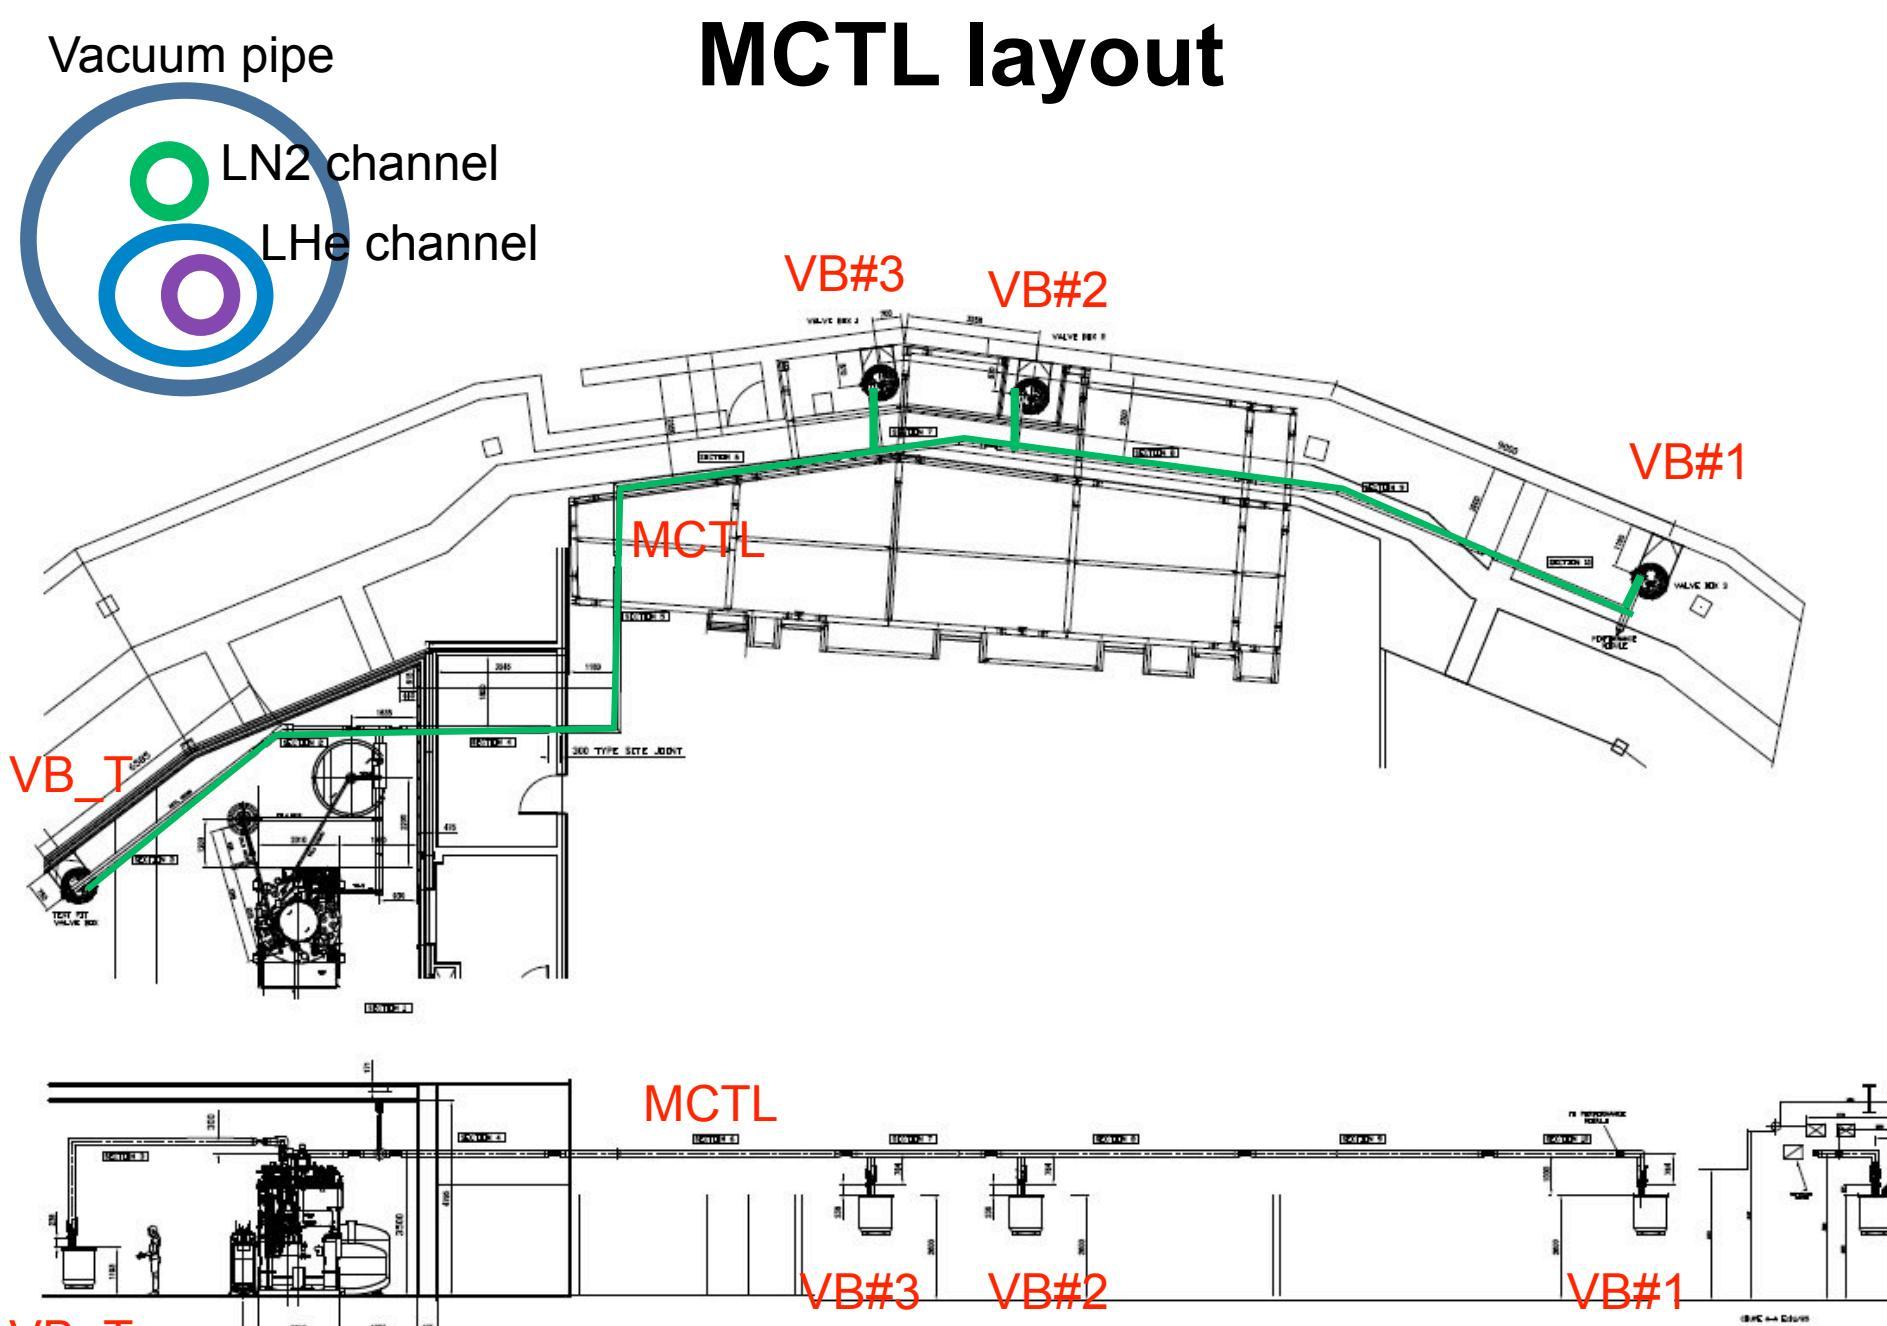
- January, MCTL break down (2 months for repair)
- October, IVU foil bump (3 IVUs)
- December, 400 mA top-up operation
